ECOLOGICAL SITE ASSESSMENT

BRACKENRIDGE PARK

Brackenridge Park Conservancy
San Antonio, Texas

August, 2019

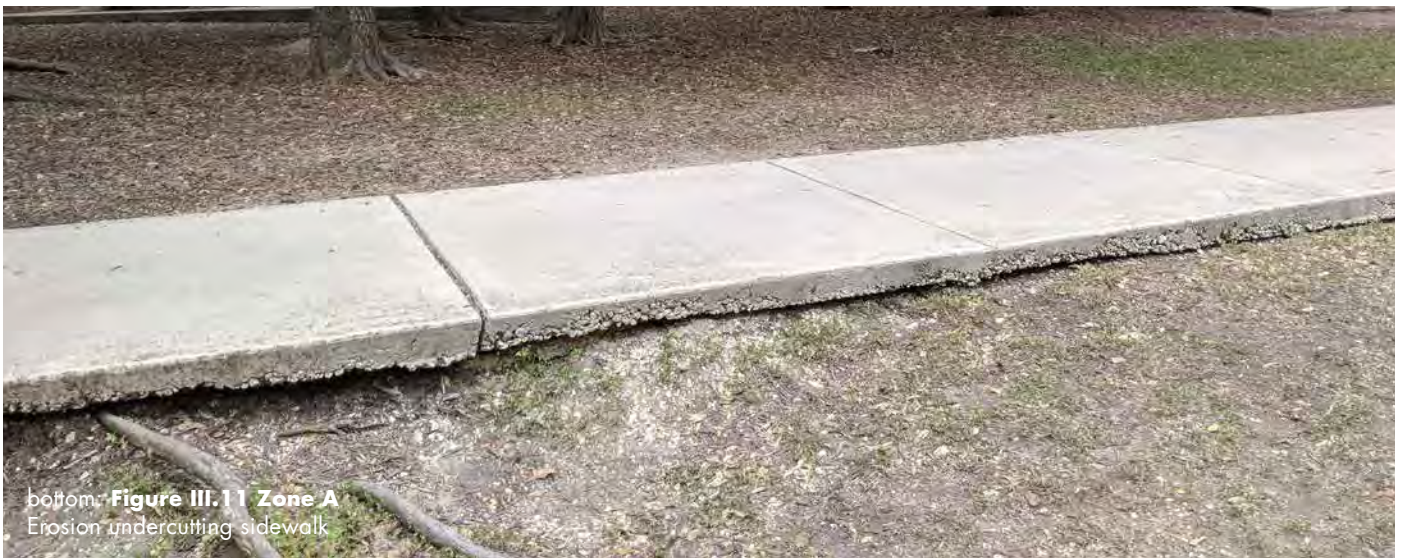
bottom: **Figure III.11 Zone A**
Erosion undercutting sidewalk

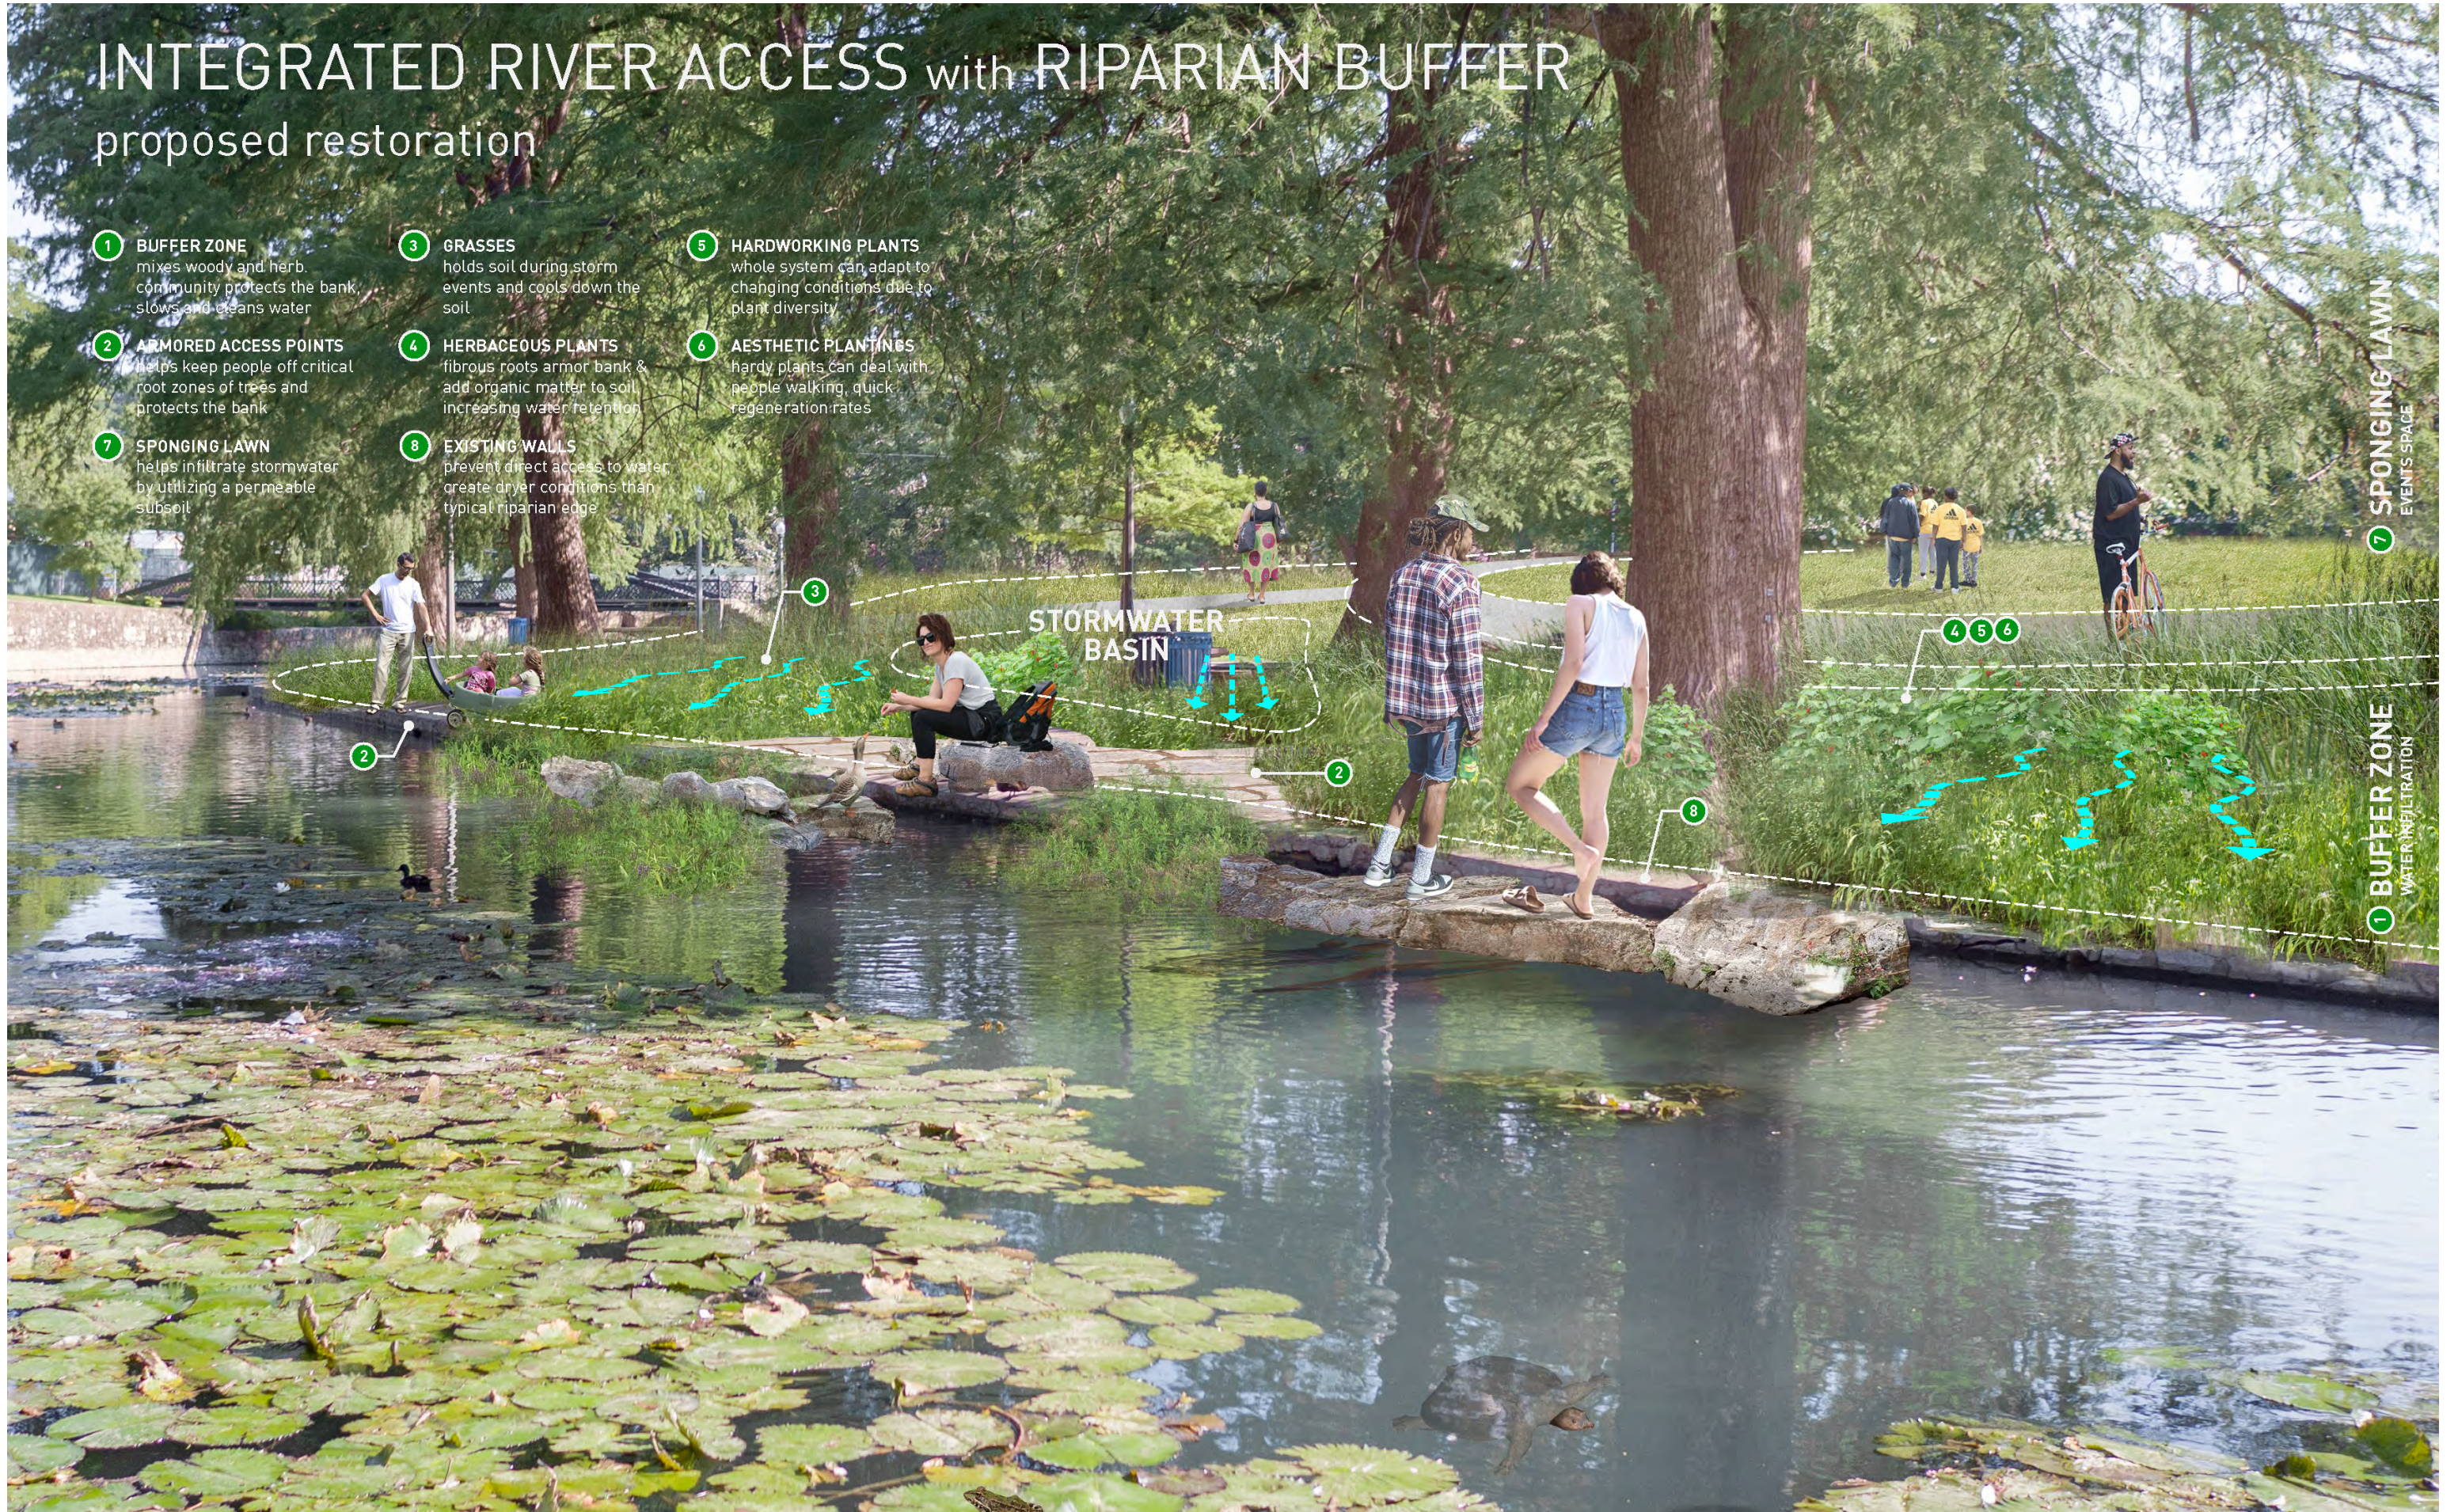
INTEGRATED RIVER ACCESS with RIPARIAN BUFFER

- 1 UNDERCUTTING SIDEWALK
erosion of surrounding soil
weakens hardscape features
- 2 SHALLOW-ROOTED PLANTS
- 3 CONTAMINANTS
no barrier to keep contaminants from the road flowing straight into river
- 4 LACK OF BIODIVERSITY
within the plant community
there is a lack of structural
species, and age diversity
- 5 HIGH VISIBILITY

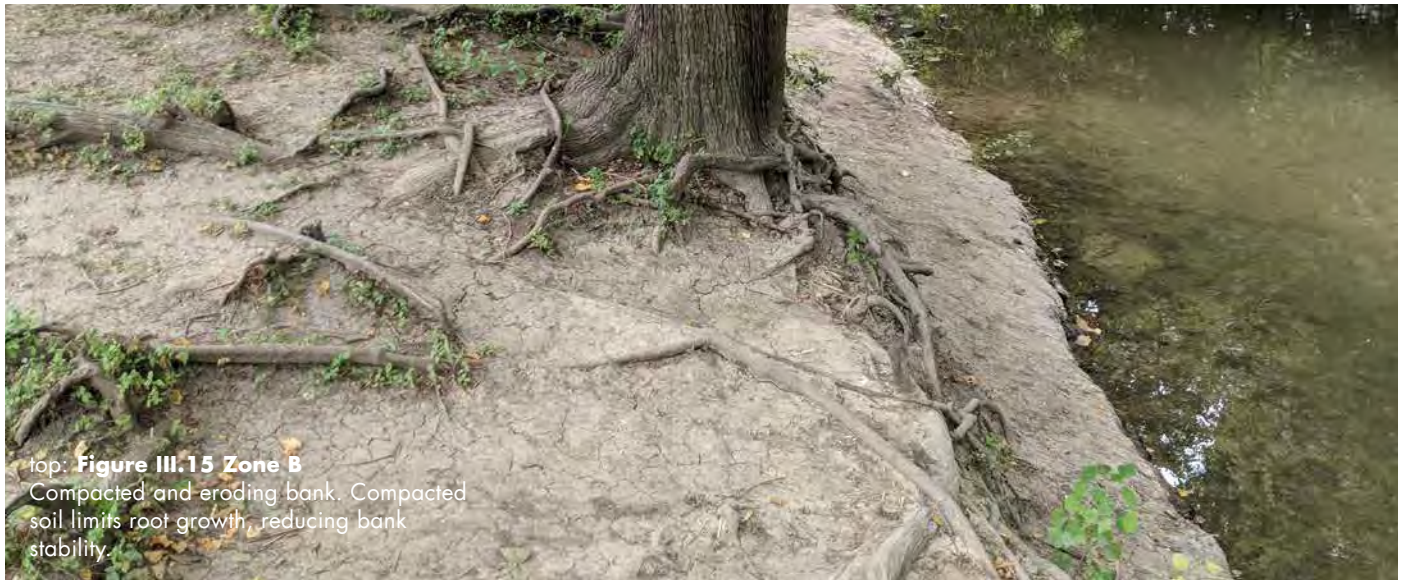
top: **Figure III.15 Zone B**
Compacted and eroding bank. Compacted soil limits root growth, reducing bank stability.

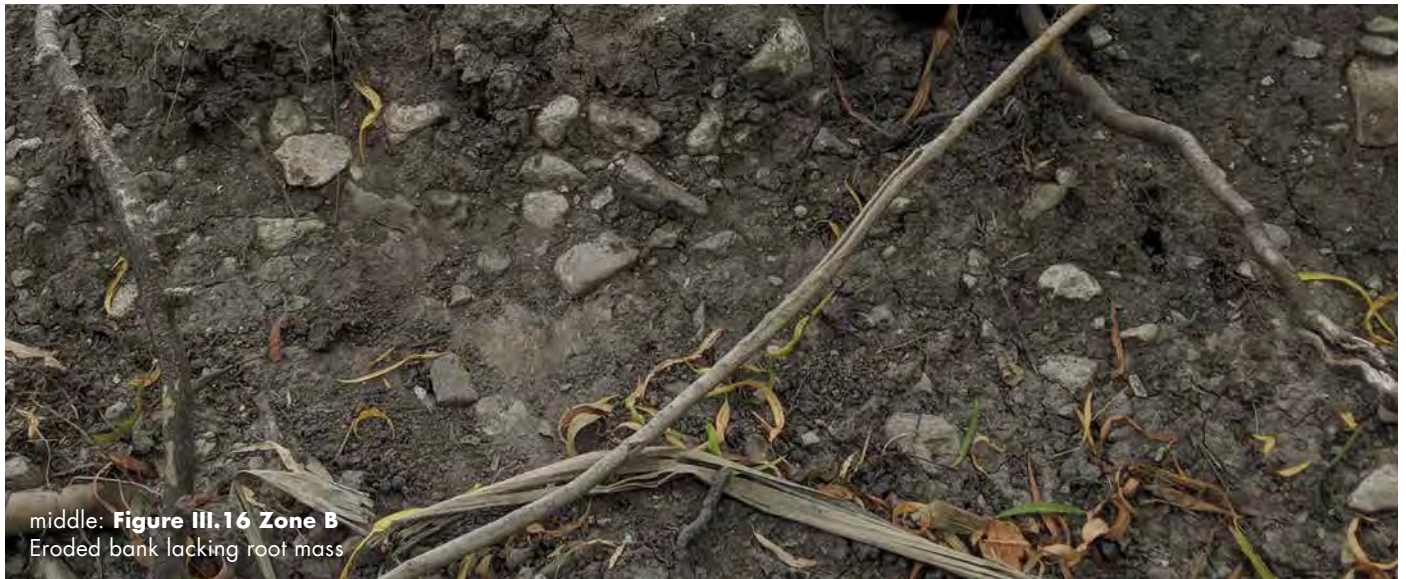
middle: **Figure III.16 Zone B**
Eroded bank lacking root mass

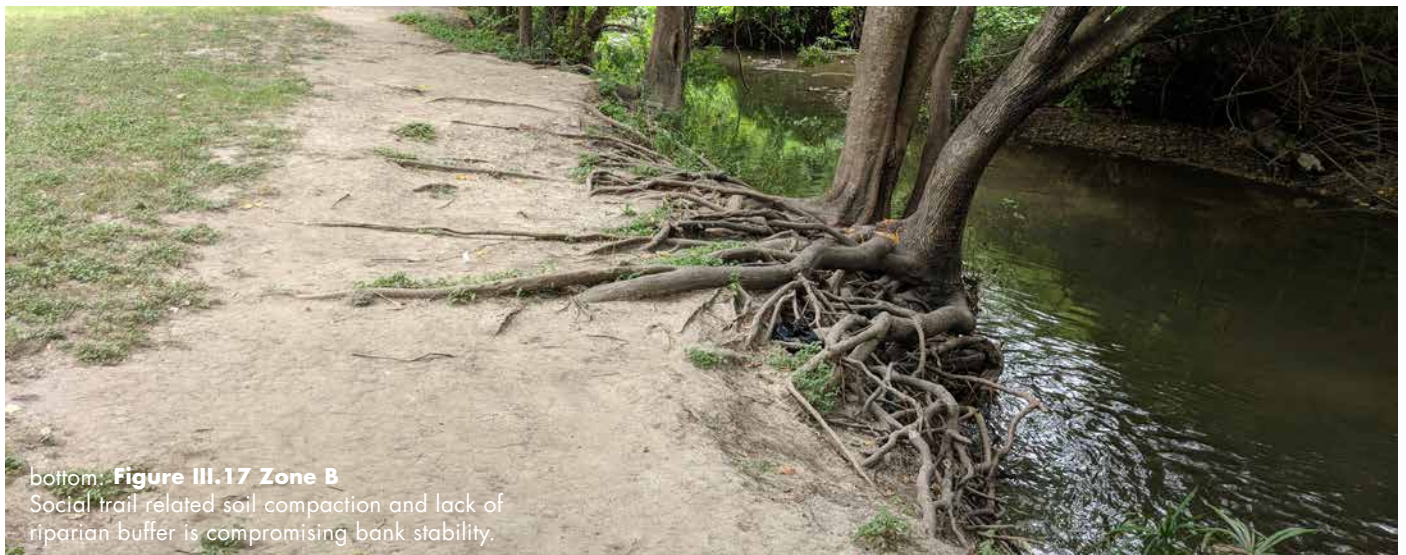
bottom: **Figure III.17 Zone B**
Social trail related soil compaction and lack of riparian buffer is compromising bank stability.

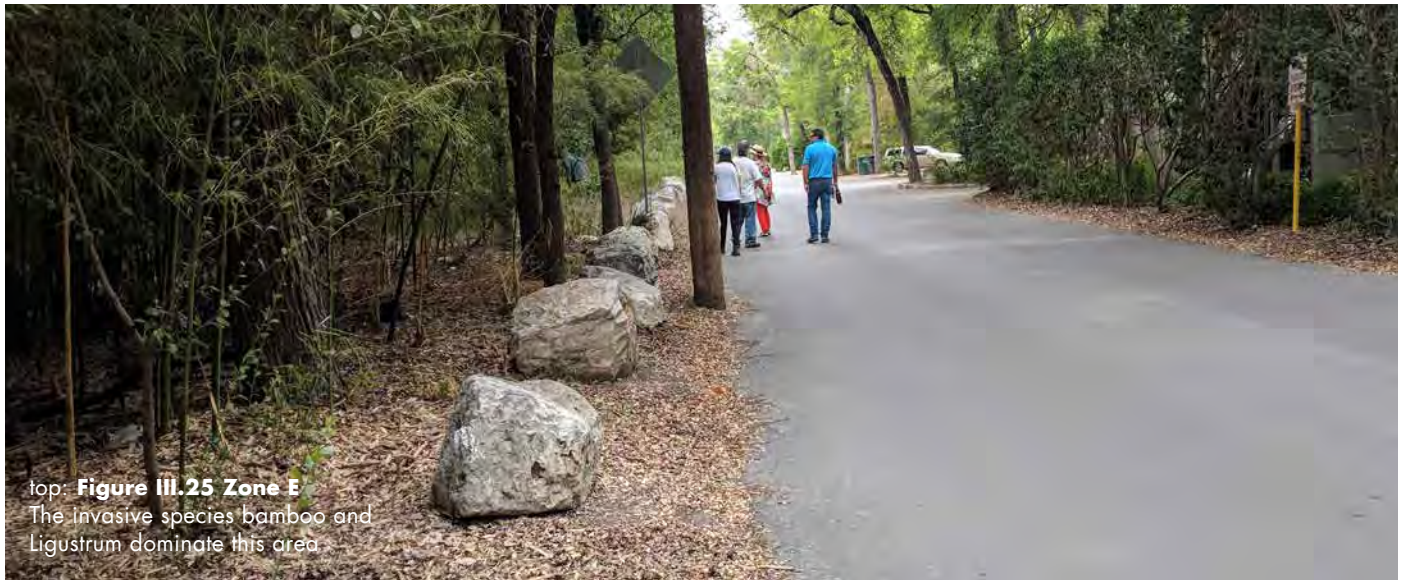
top: **Figure III.25 Zone E**
The invasive species bamboo and Ligustrum dominate this area

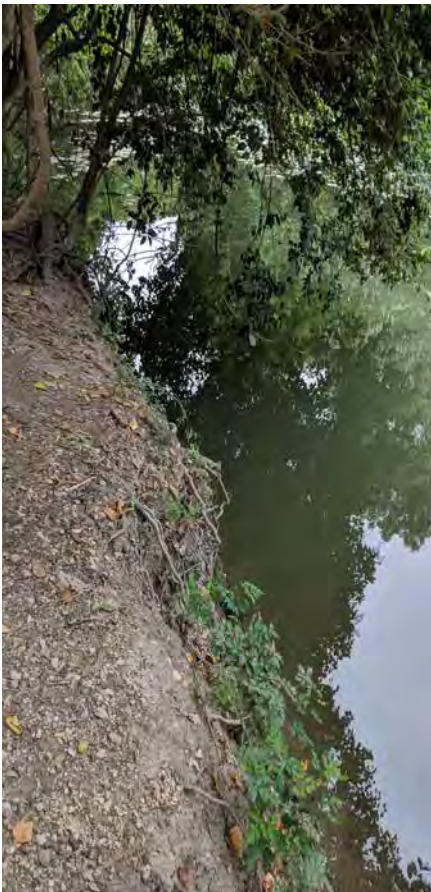
top: **Figure III.28 Zone F**
Riparian vegetation as been removed for access, resulting in accelerated erosion

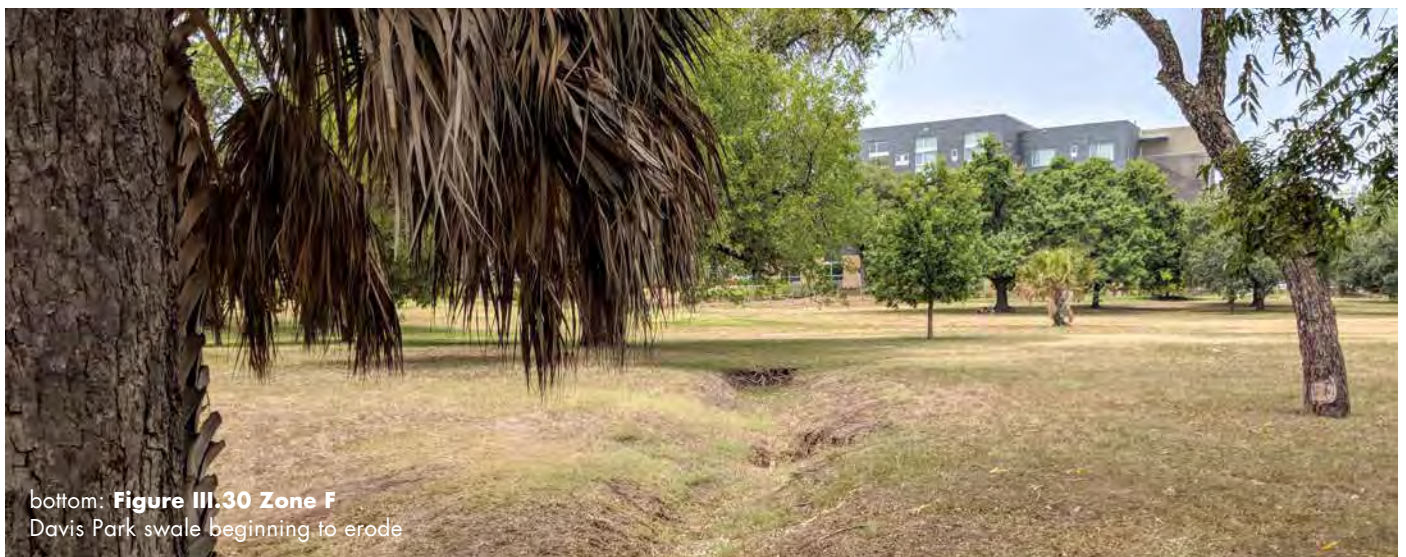
bottom: **Figure III.30 Zone F**
Davis Park swale beginning to erode

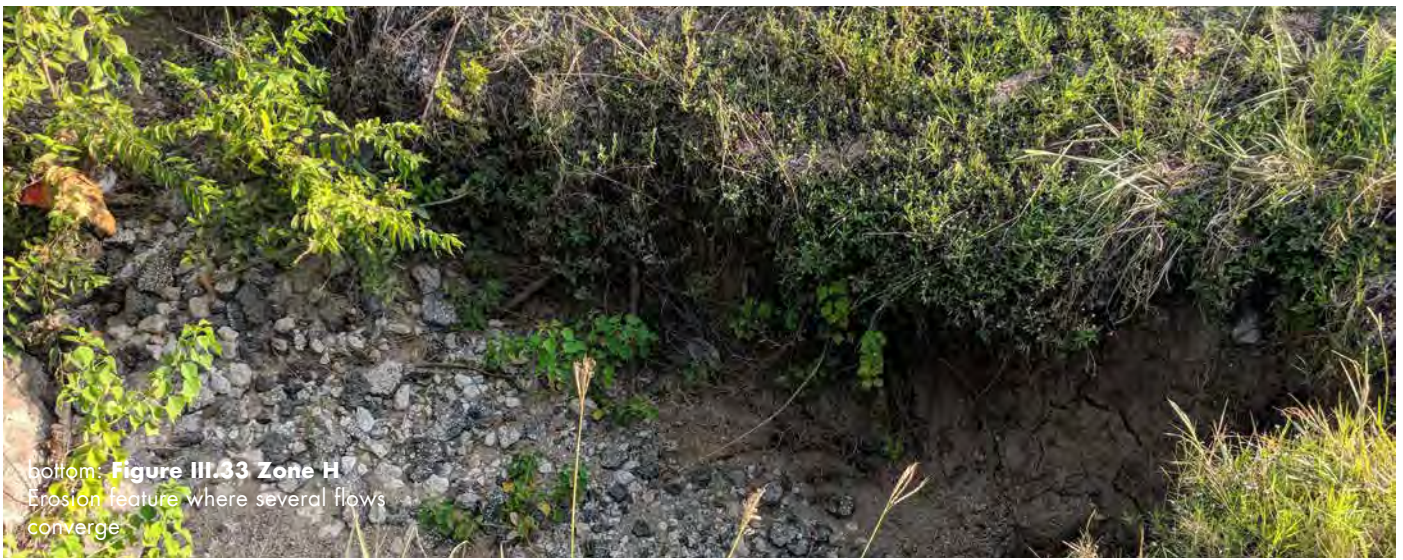
bottom: **Figure III.33 Zone H**
Erosion feature where several flows converge

Opportunities: SARA conducted an overland flow analysis of the area which reveals that a substantial area is draining to this swale and converging on the erosion point.

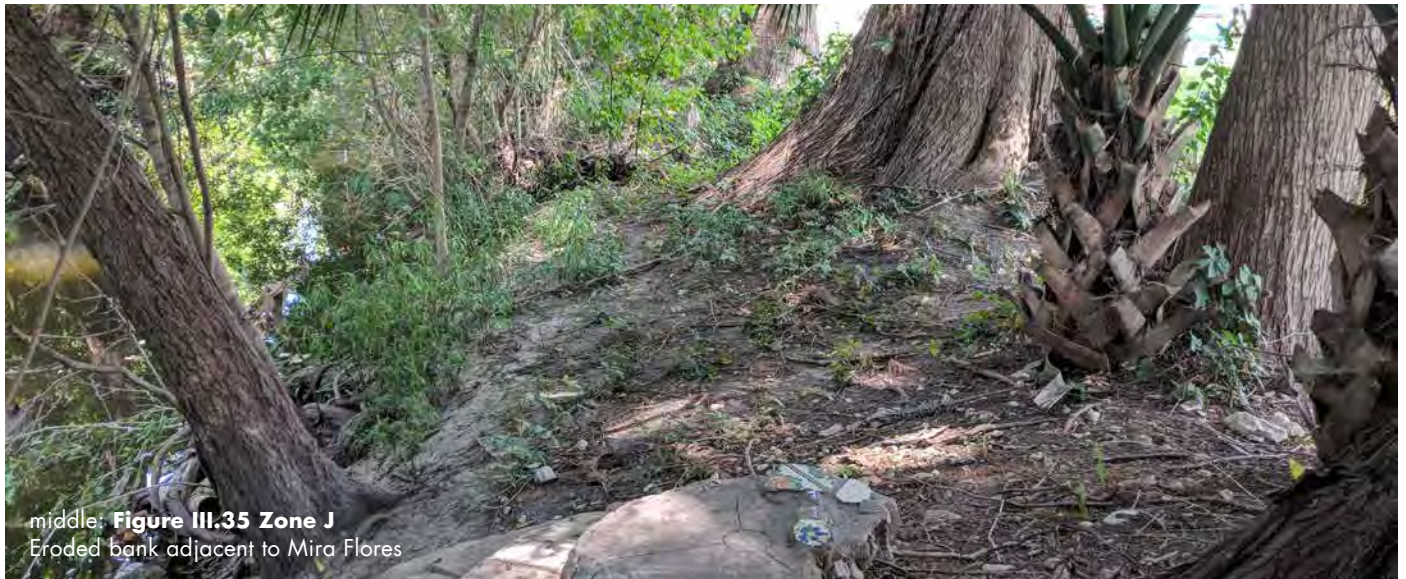
middle: **Figure III.35 Zone J**
Eroded bank adjacent to Mira Flores

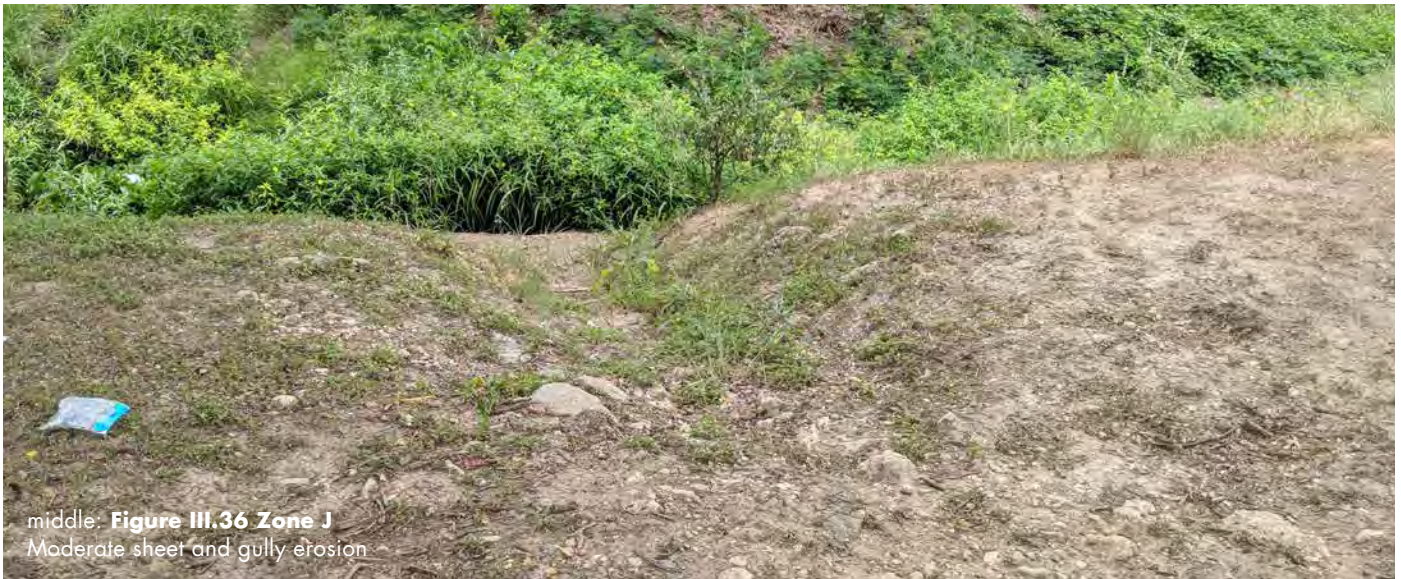
middle: **Figure III.36 Zone J**
Moderate sheet and gully erosion
