ECOLOGICAL SITE ASSESSMENT

BRACKENRIDGE PARK

Brackenridge Park Conservancy
San Antonio, Texas

August, 2019

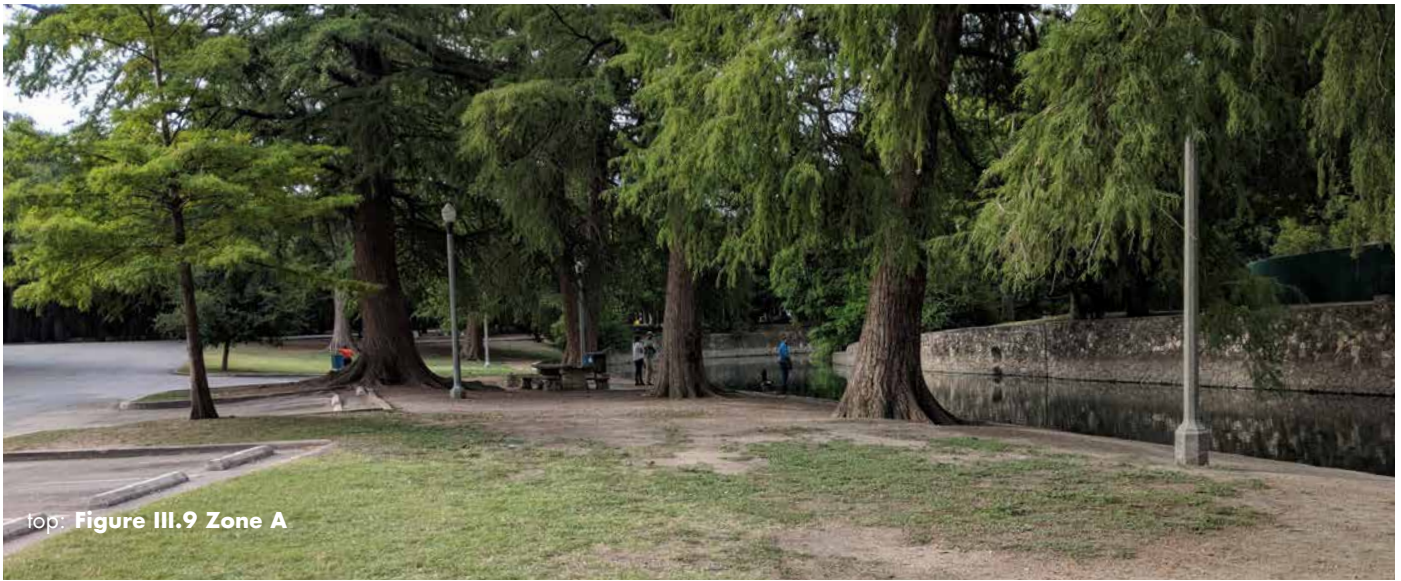
top: **Figure III.9 Zone A**

The area east of Brackenridge Way, containing Conservancy Headquarters, Joske Pavilion, and the play area similarly lacks midstory and a functional herbaceous

The Wildflower Center has created an illustrative design for this zone to demonstrate combining human use and ecological goals in a high use area which is illustrated in the following pages.

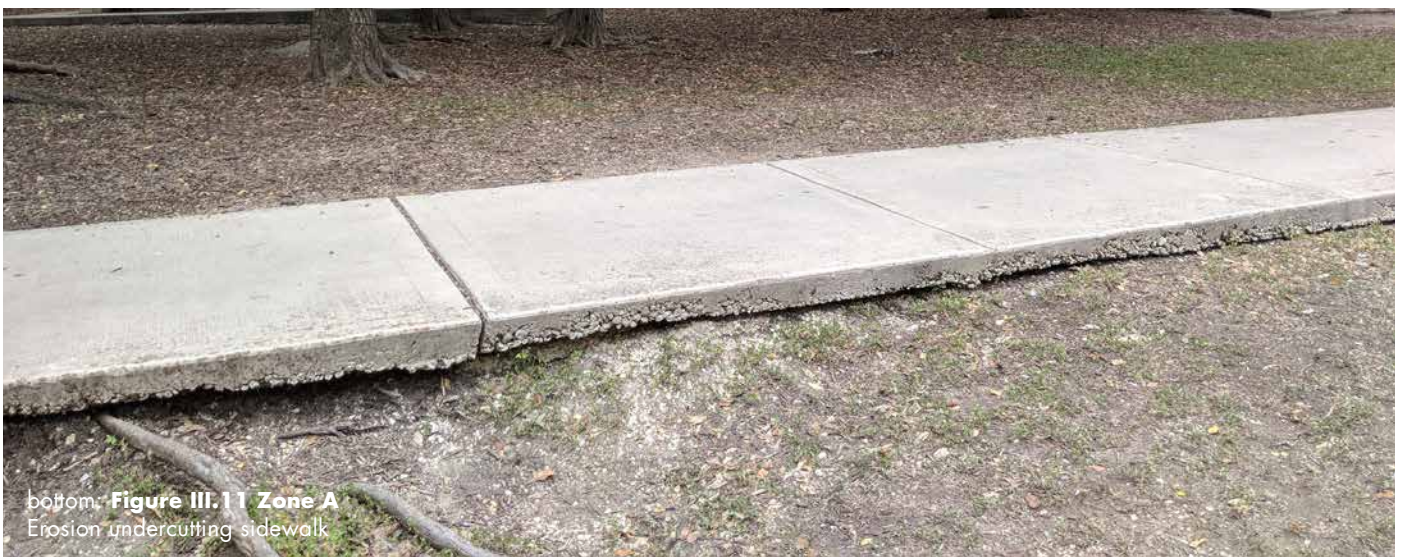
bottom: **Figure III.11 Zone A**
Erosion undercutting sidewalk

layer. Mature trees include live oak, cedar elm, and pecan. Also present are mature crape myrtles (*Lagerstroemia indica*). Bermudagrass and straggler daisy make up the herbaceous layer, when present. The soil is severely compacted.

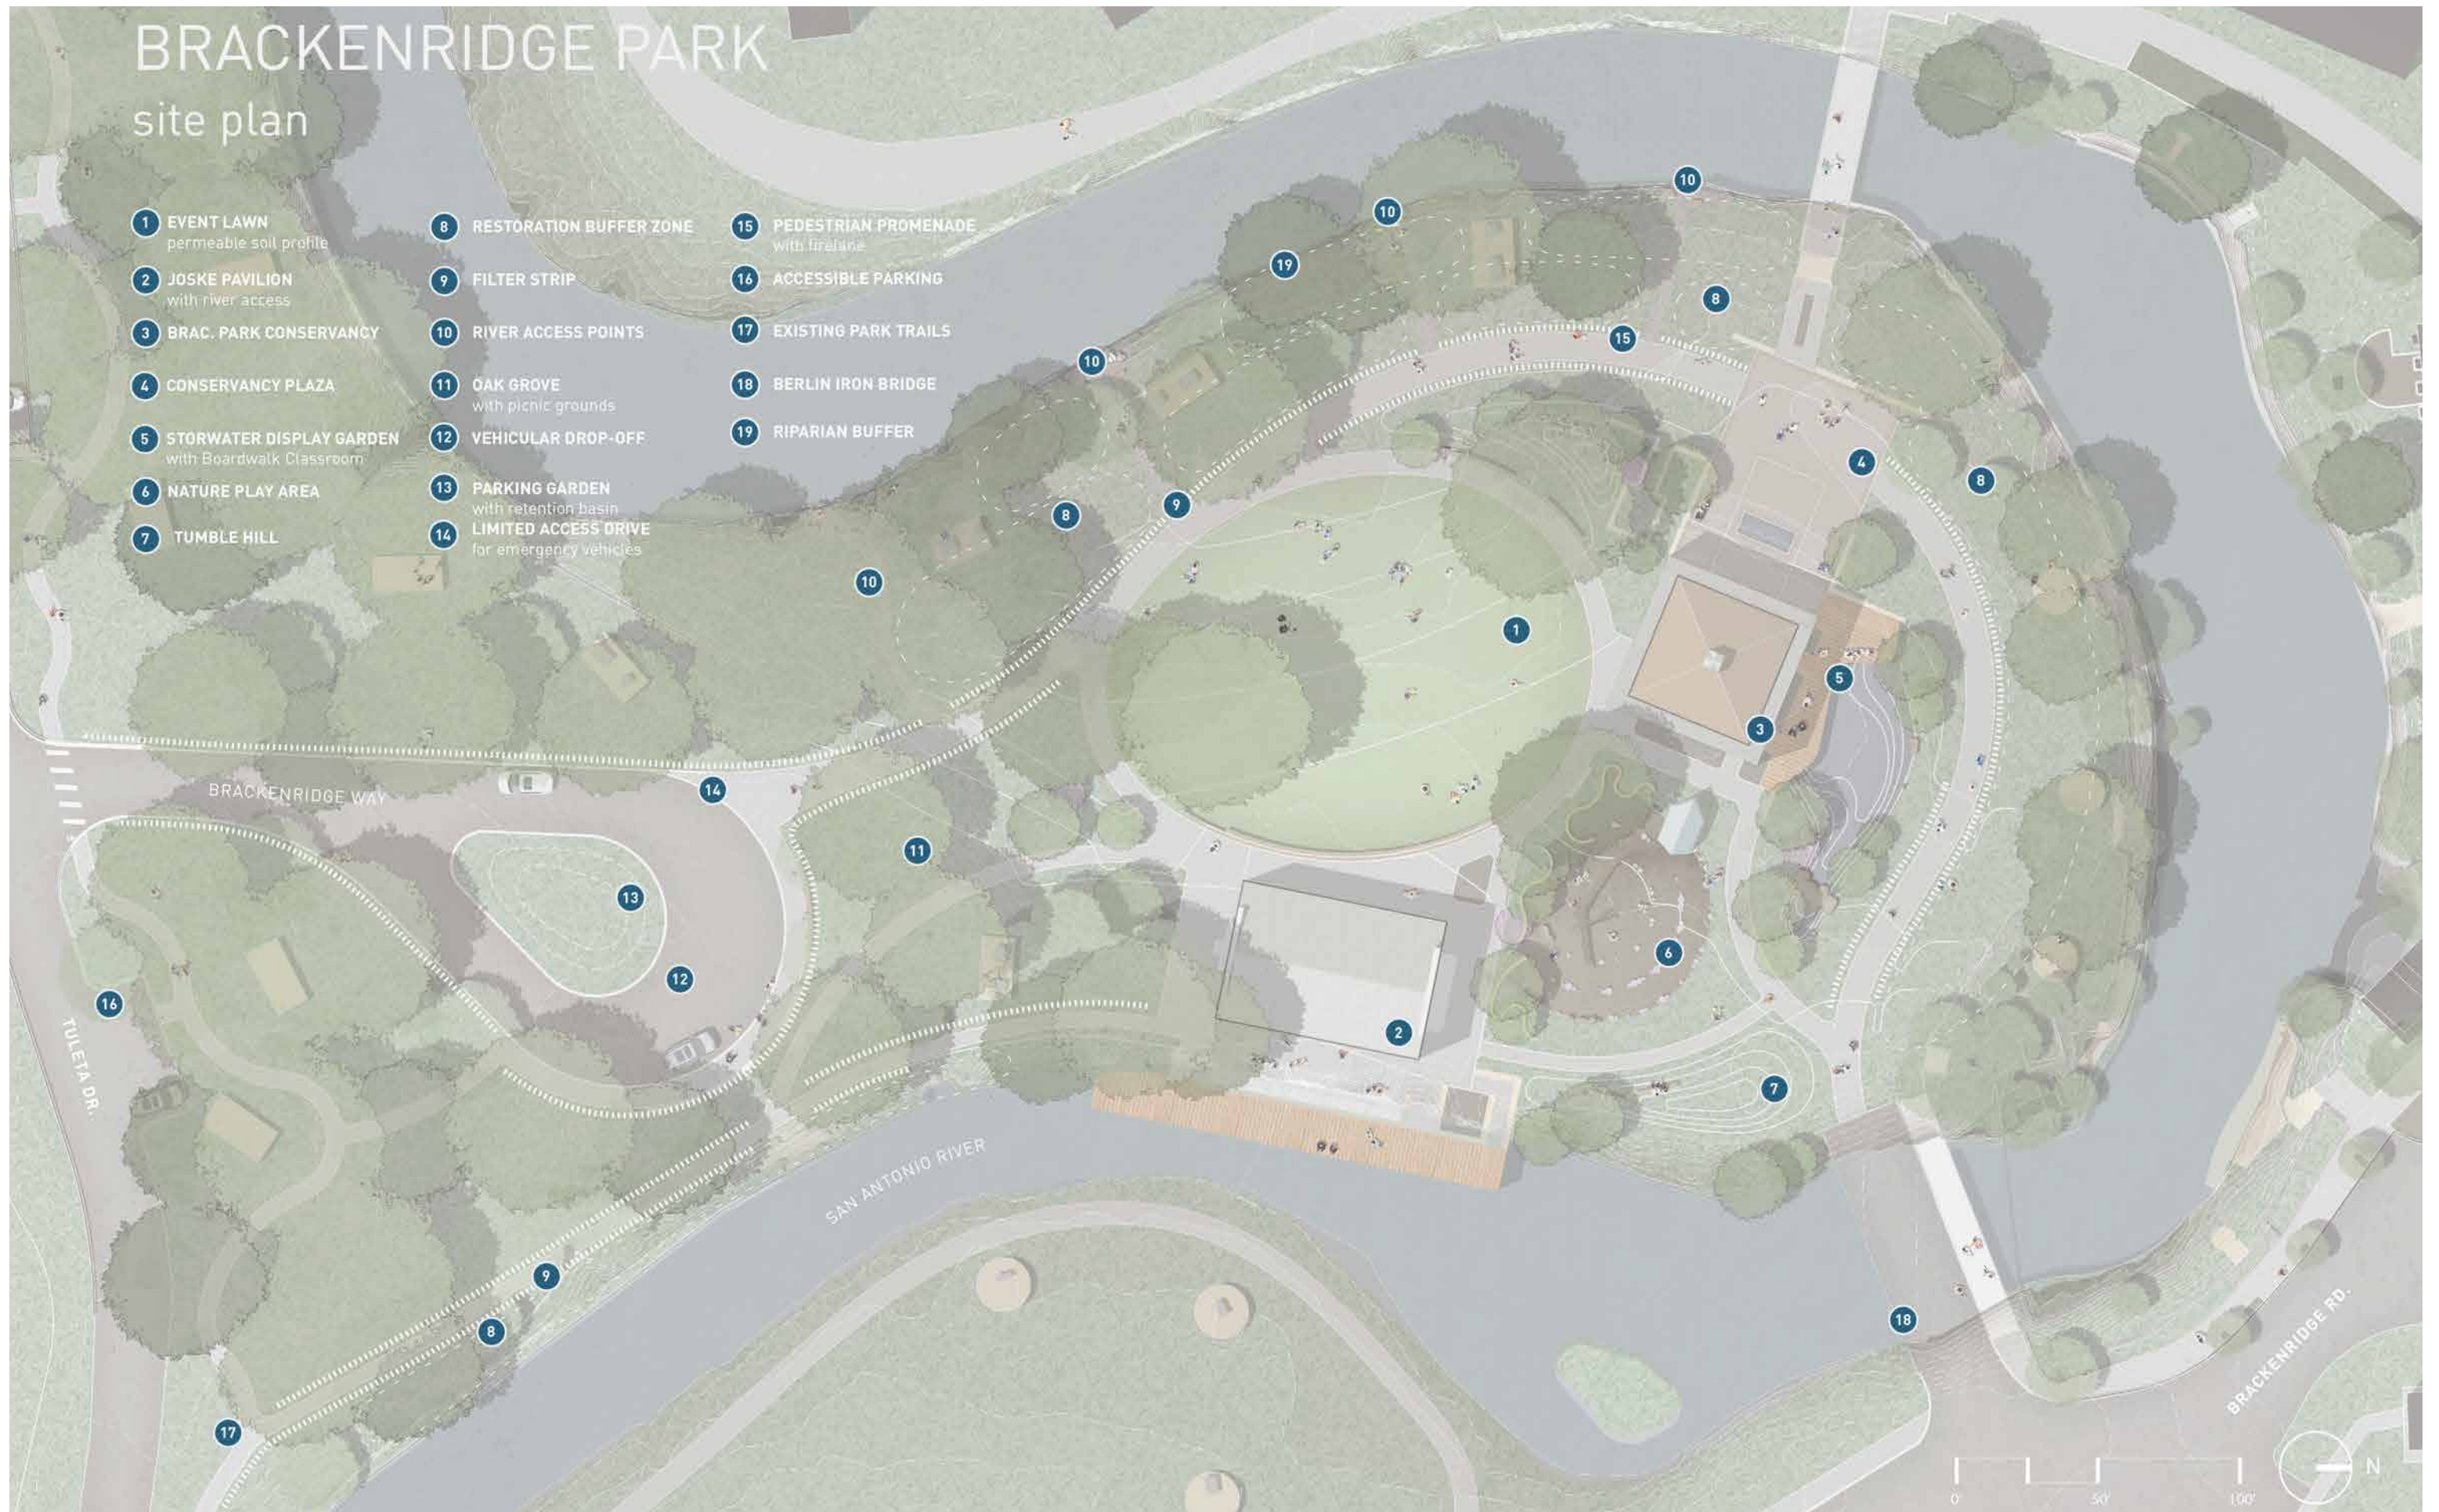
INTEGRATED RIVER ACCESS with RIPARIAN BUFFER

- 1 **EXPPOSED SOILS**
water flows uninterrupted to river's edge carrying soil and contaminants
- 2 **INCREASE SOIL TEMPERATURE**
fluctuations in temperature stress plants and soil biota
- 3 **RUNOFF POTENTIAL**
poor soil health decreases its ability to filter water
- 4 **LACK OF BIODIVERSITY**
within the plant community there is a lack of structural species and age diversity
- 5 **INCREASE IN CONTAMINANTS**
increased potential of contaminant runoff from vehicular parking
- 5 **EXISTING WALLS**
prevent direct access to water creates dryer conditions than typical riparian edge
- 7 **COMPACTED SOILS**
cannot absorb or hold water and stress roots

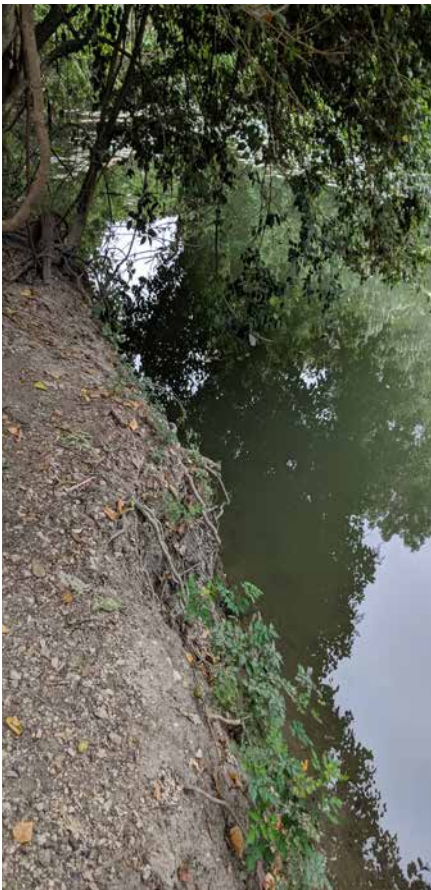
top: **Figure III.28 Zone F**
Riparian vegetation as been removed
for access, resulting in accelerated
erosion

dominates the overstory and midstory. Chinaberry and giant cane (*Arundo donax*) are common. Severe erosion exists at several points where the buffer has been removed to facilitate access (Figure III.28). Native species contribute less than 30% to overall cover. The overstory contains scattered pecans and live oaks and the midstory hosts hackberry, boxelder and an elderberry thicket (*Sambucus nigra*) on the western bank. The ground story is dominated by the native poison ivy (*Toxicodendron radicans*) and ragweed, with occasional frogfruit (*Phyla nodiflora*), turkscap (*Malvaviscus arboreus*), and inland sea oats. Seedlings are predominantly invasive Japanese privet and native boxelder. The buffer is narrow on both sides of the creek, limited on the east by Avenue A and to the west by mowed areas adjacent to River Road.

The riparian area stands to gain substantially from restoration efforts. The reach would benefit from widening the buffer to 50 to 100 feet on both sides with integrated landings for fishing and river viewing. Narrowing the mowed area to the west and the road to the east would allow the buffer to expand enough to influence bank stability and water quality. The bank is nearly vertical in many areas and re-contouring to reduce slope and reconnect the river to the floodplain is needed. This work, combined with invasive species removal, will significantly reduce overall vegetative cover and must be accompanied by revegetation and temporary erosion control. Revegetation should combine seeding and live planting. Temporary irrigation for establishment is strongly encouraged. Revegetation efforts should include a high proportion of colonizer and stabilizer grasses and sedges to cover and hold the bank quickly while woody species grow in. Sideoats grama, green sprangletop and goldenrod provide quick coverage in dryer, sunny areas. Nearer to the bank Emory sedge, Eastern gammagrass and switchgrass, installed as a live plantings, are important stabilizers. Shaded areas can include inland seaoats and Virginia wildrye. Black willow and boxelder, already present in the area, spread quickly and can provide initial coverage. Both species can become overabundant at times and may require thinning. The woody community can be enhanced with buttonbush, little walnut, sycamore, pecan and bald cypress.

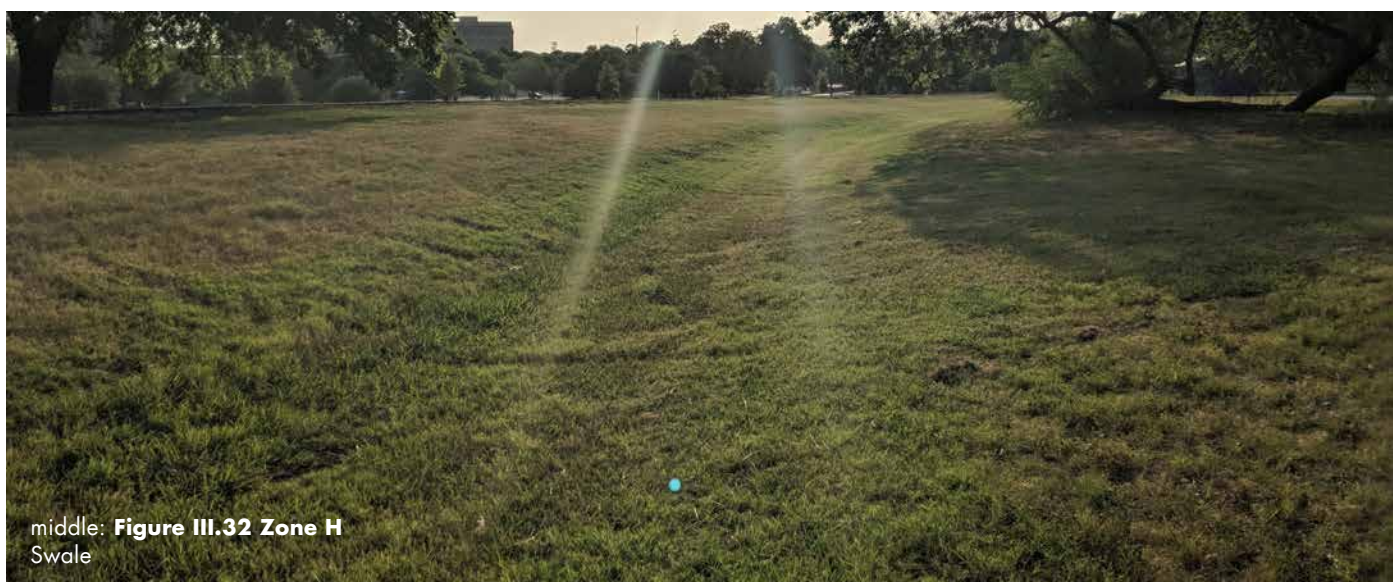
middle: **Figure III.32 Zone H**
Swale

A system of stormwater gardens and restored landscape in this area could reduce the flow. Enhancing swale diversity and mowing at a higher level would increase its functionality. Ideally the swale and immediate contributing zone will contain densely rooted mid-grass species that can better tolerate the level of flow.

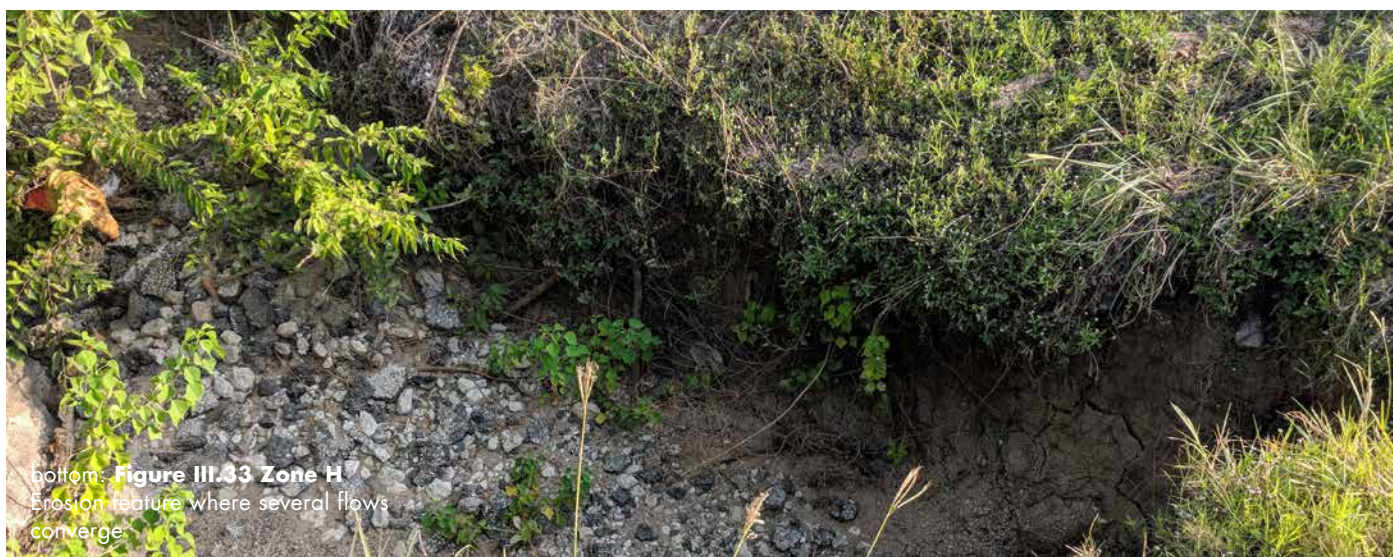
Opportunities: SARA conducted an overland flow analysis of the area which reveals that a substantial area is draining to this swale and converging on the erosion point.

bottom: **Figure III.33 Zone H**
Erosion feature where several flows converge

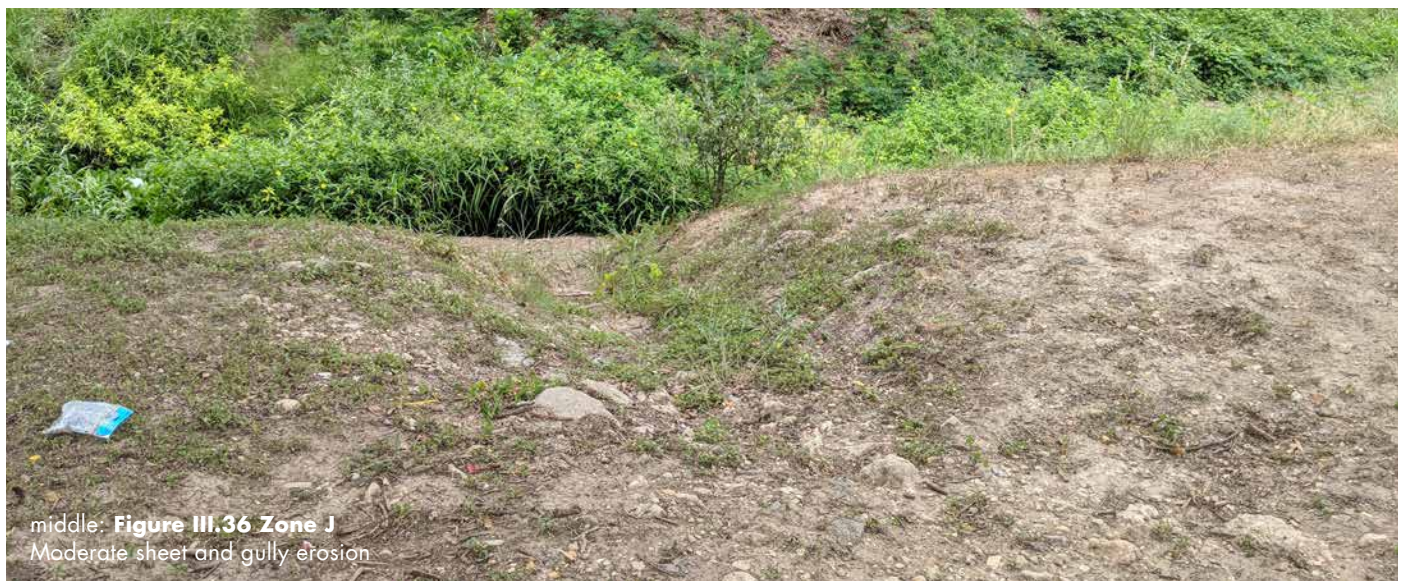
middle: **Figure III.36 Zone J**
Moderate sheet and gully erosion

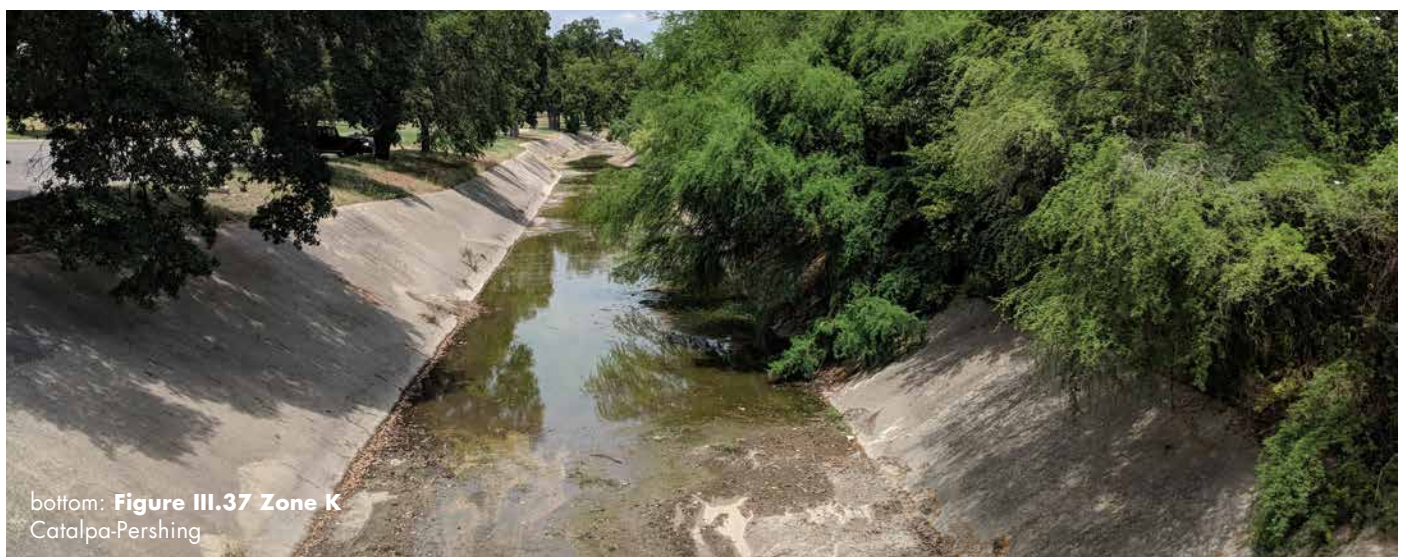
bottom: **Figure III.37 Zone K**
Catalpa-Pershing

Opportunities: Restoration of Catalpa Pershing will require a multidisciplinary design team including engineers, design professionals, ecologists, soil scientists, maintenance professionals and members of owner organizations. The recommendations made here assume that naturalization of the channel is the goal as described in the master plan, and pertain only to ecological considerations. Engineering, human experience, historical/cultural considerations and connectivity will need to be considered as well.

The natural channel design should be based on hydrologic and hydraulic modelling to ensure the channel conducts stormwater appropriately and to determine the appropriate ratio and location of naturalized vs. reinforced banks. The goal is to incorporate meander, reduce bank slope, allow for bank revegetation and create complex in-stream habitat. If allowable within modelling constraints, incorporate obstructions to simulate the role of large woody debris in creating further habitat complexity and varied depositional patterns.
