ECOLOGICAL SITE ASSESSMENT

BRACKENRIDGE PARK

Brackenridge Park Conservancy
San Antonio, Texas

August, 2019

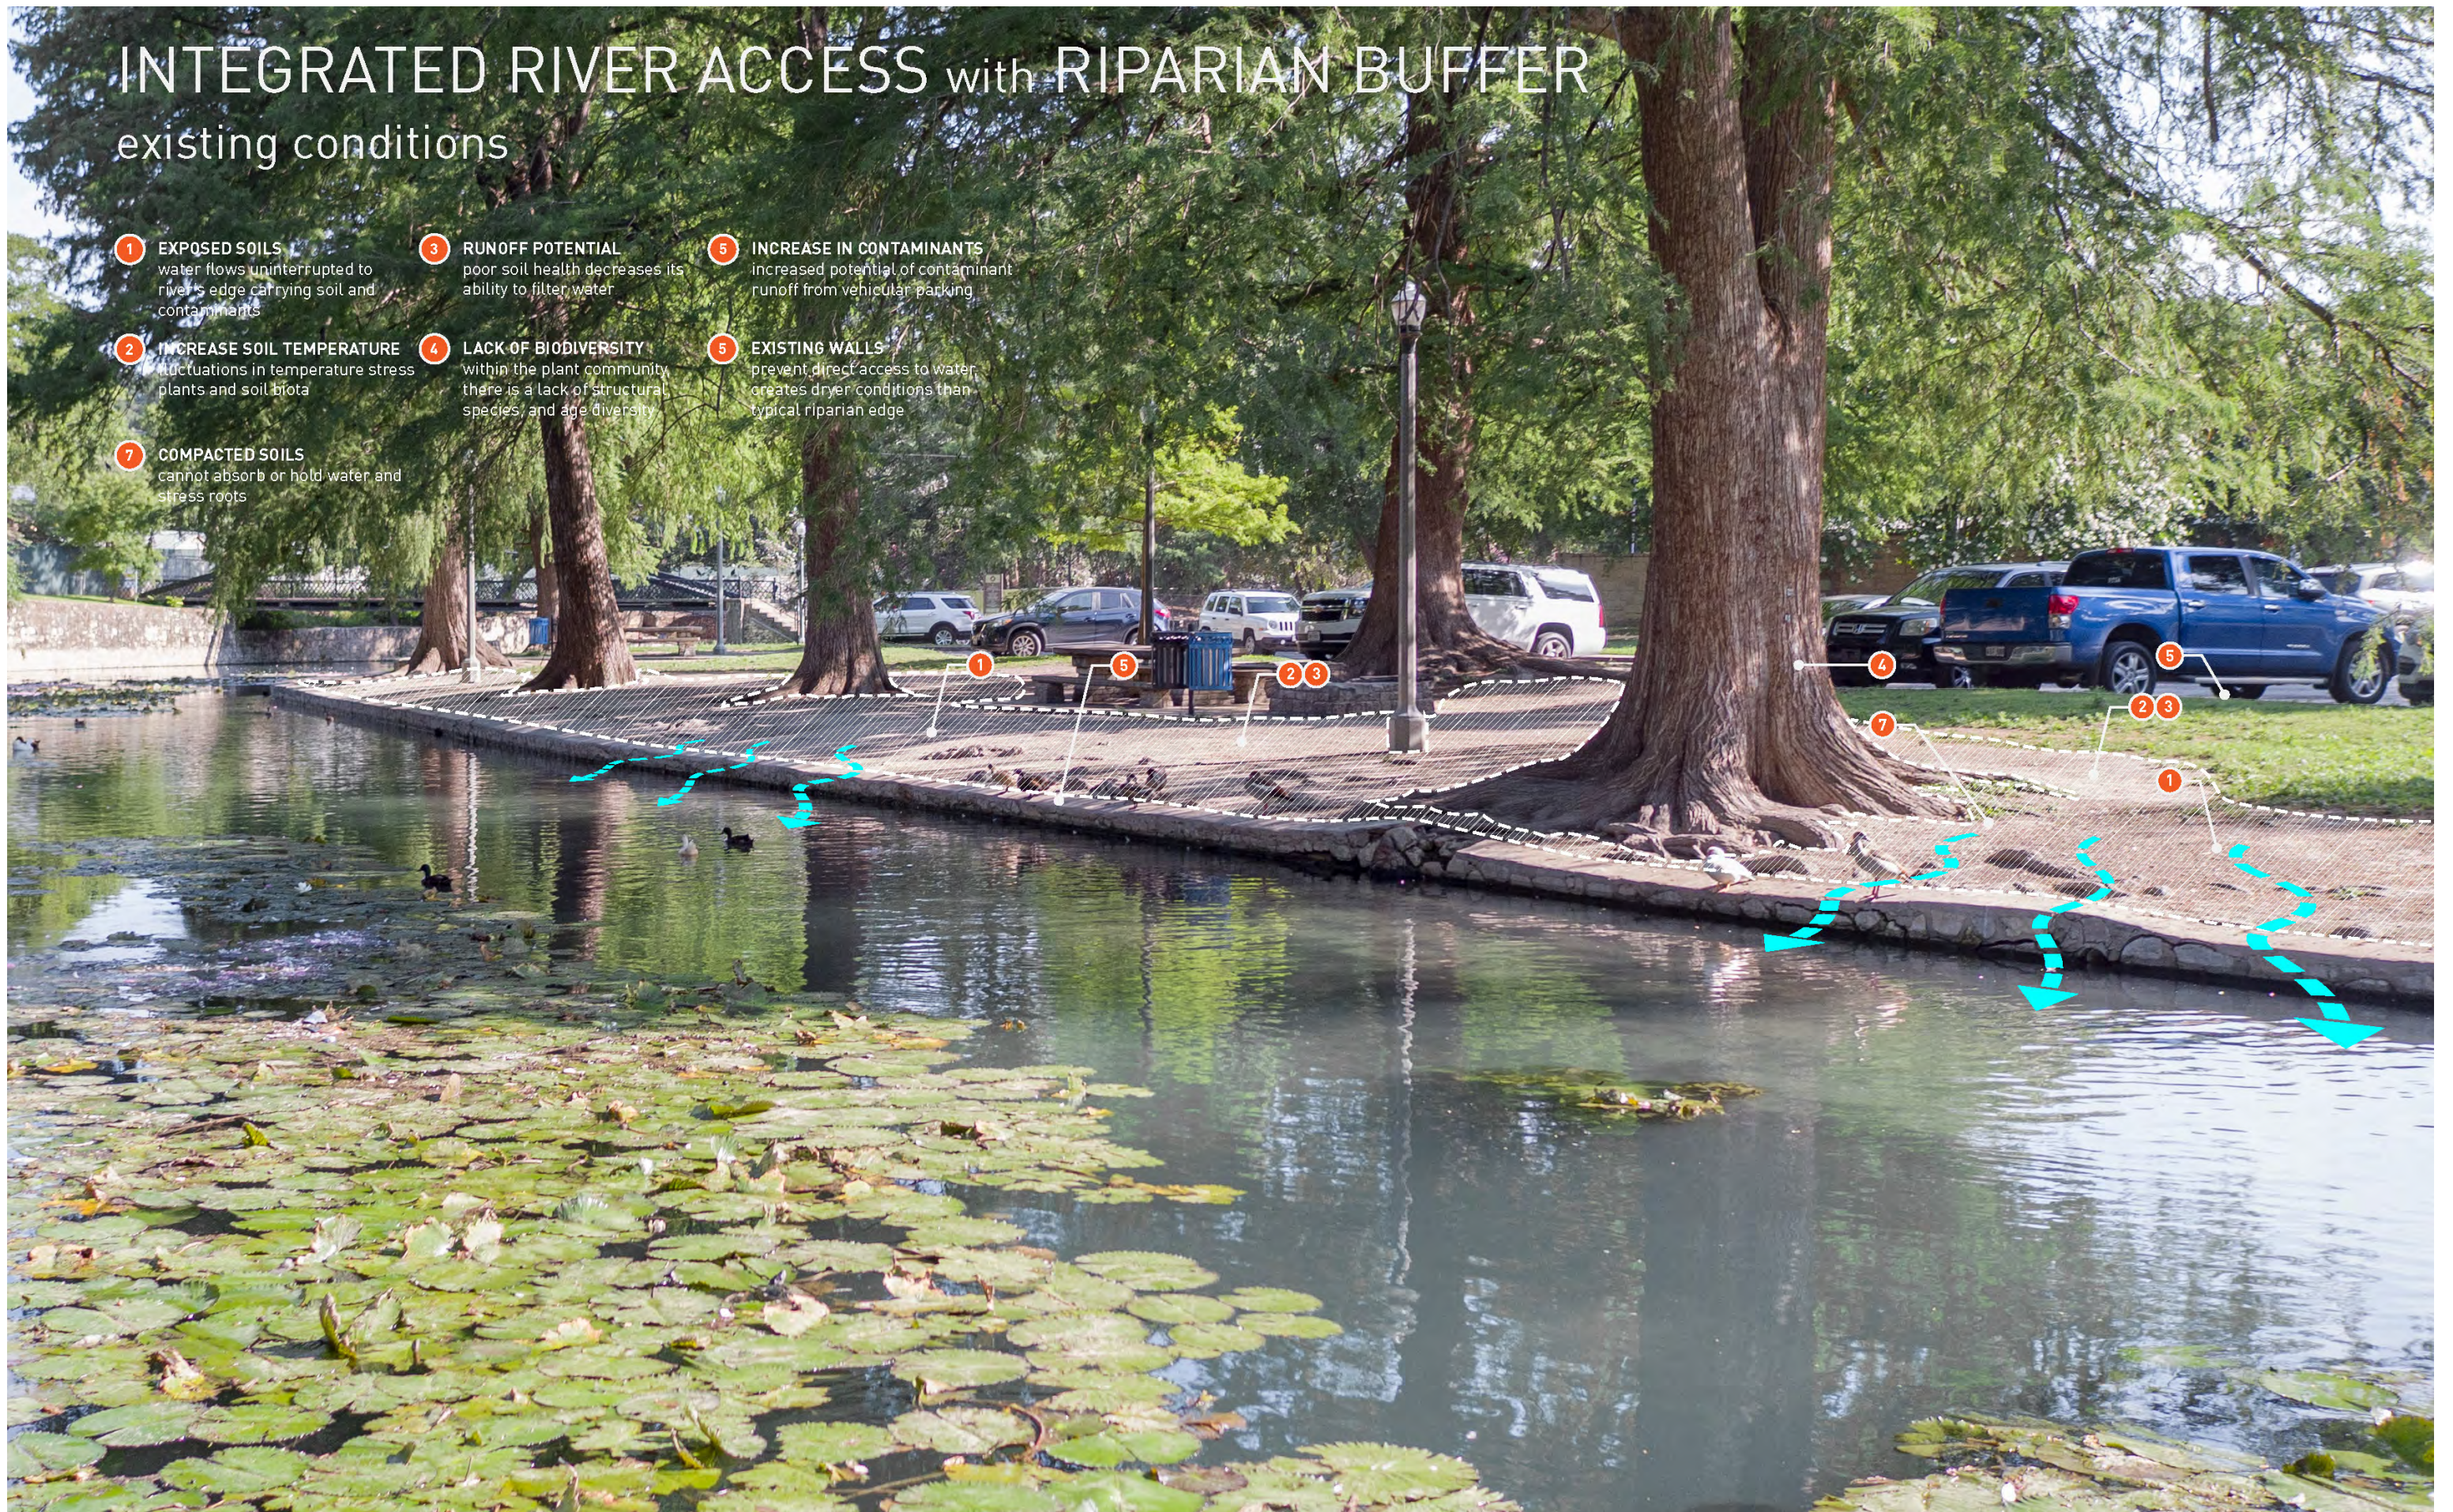
existing conditions

- 1 EXPOSED SOILS**
water flows uninterrupted to river's edge carrying soil and contaminants
- 2 INCREASE SOIL TEMPERATURE**
fluctuations in temperature stress plants and soil biota
- 3 RUNOFF POTENTIAL**
poor soil health decreases its ability to filter water
- 4 LACK OF BIODIVERSITY**
within the plant community there is a lack of structural species and age diversity
- 5 INCREASE IN CONTAMINANTS**
increased potential of contaminant runoff from vehicular parking
- 6 EXISTING WALLS**
prevent direct access to water creates dryer conditions than typical riparian edge
- 7 COMPACTED SOILS**
cannot absorb or hold water and stress roots

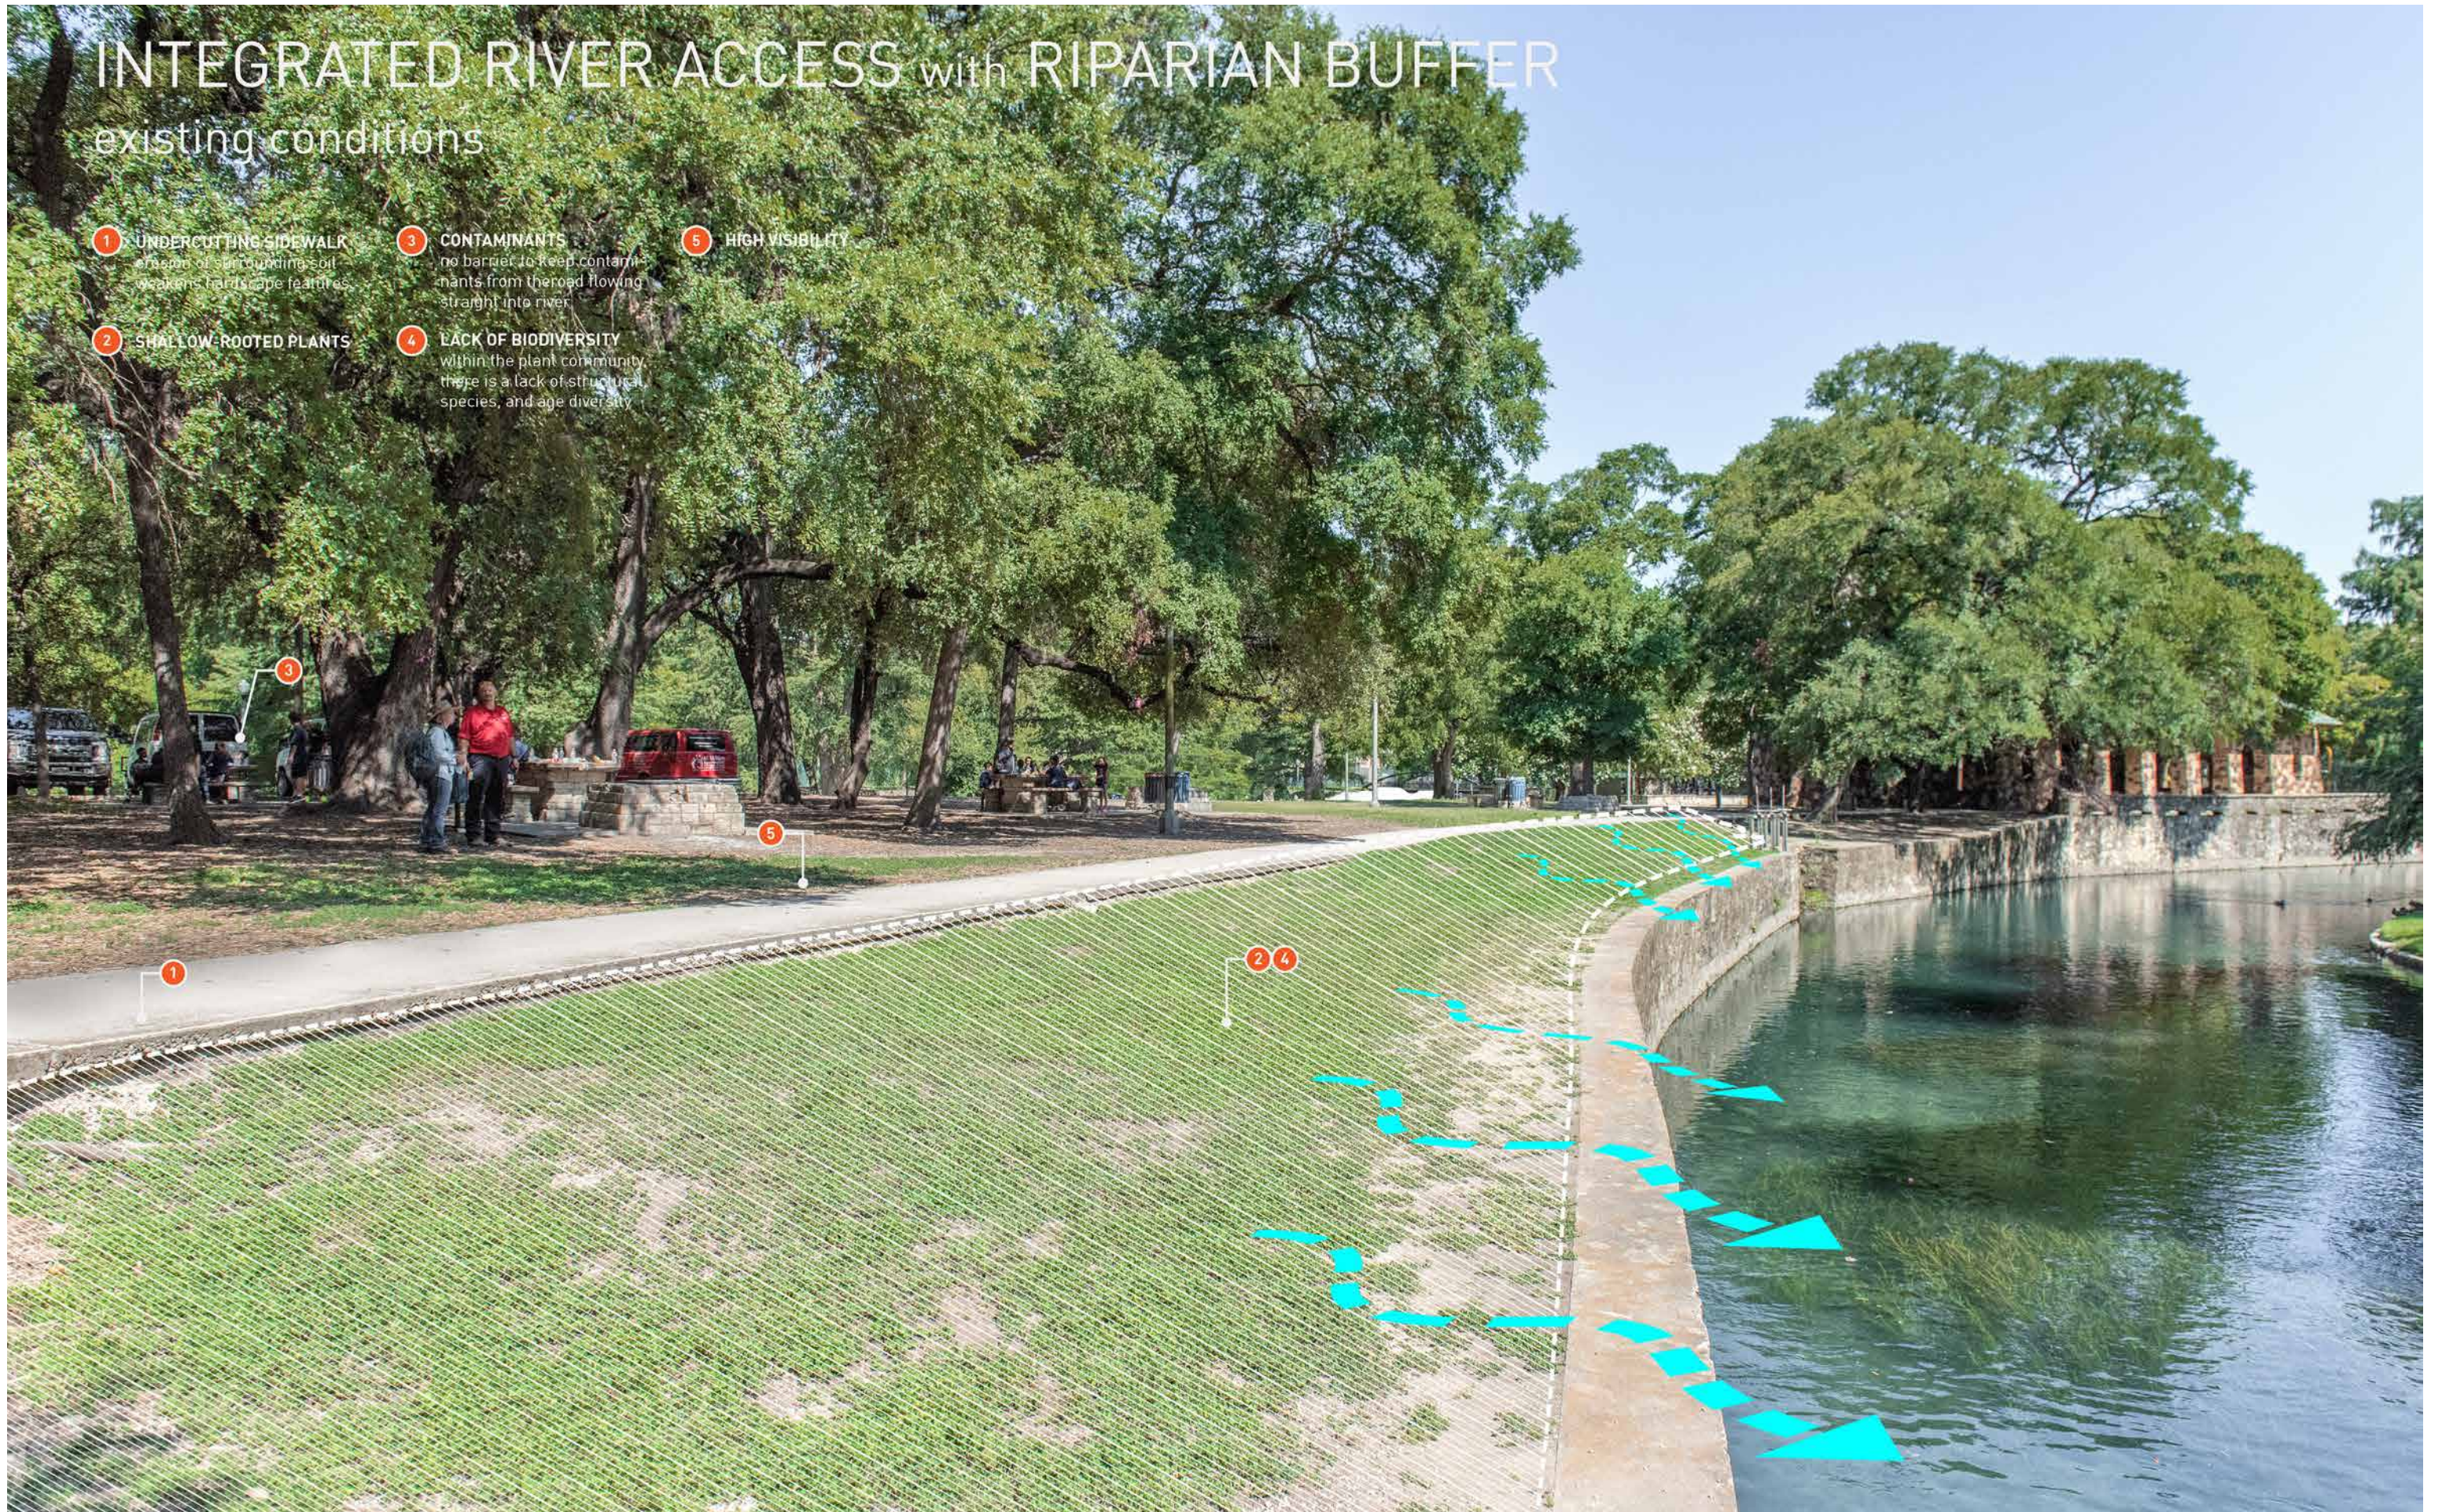
existing conditions

- 1 UNDERCUTTING SIDEWALK
erosion of surrounding soil
weakens hardscape features
- 2 SHALLOW-ROOTED PLANTS
- 3 CONTAMINANTS
no barrier to keep contaminants from the road flowing straight into river
- 4 LACK OF BIODIVERSITY
within the plant community
there is a lack of structural
species, and age diversity
- 5 HIGH VISIBILITY

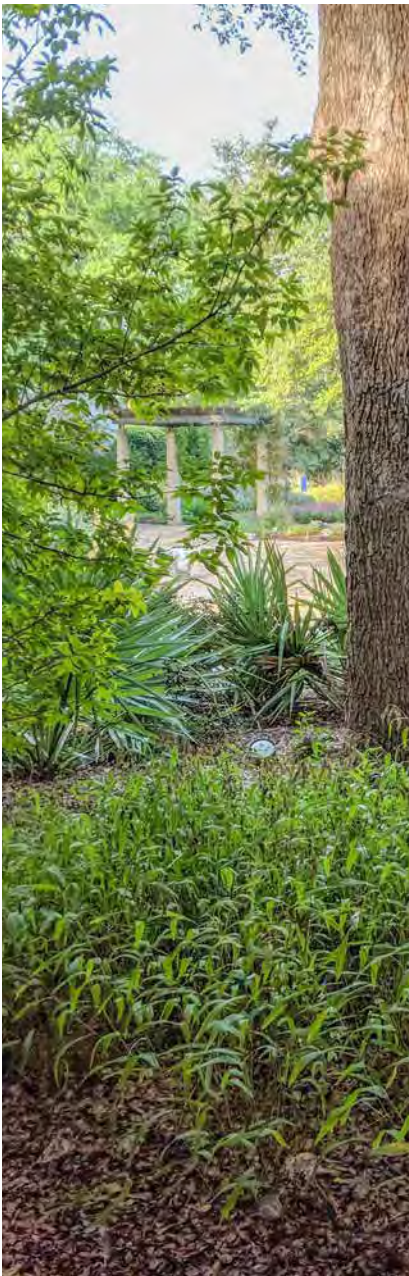
top: **Figure III.18 Protective planting**
 Low to knee high plantings can be used to cool and protect critical root zones and to influence traffic patterns. Maintenance requirements of plantings must be matched with maintenance capacity for the area.

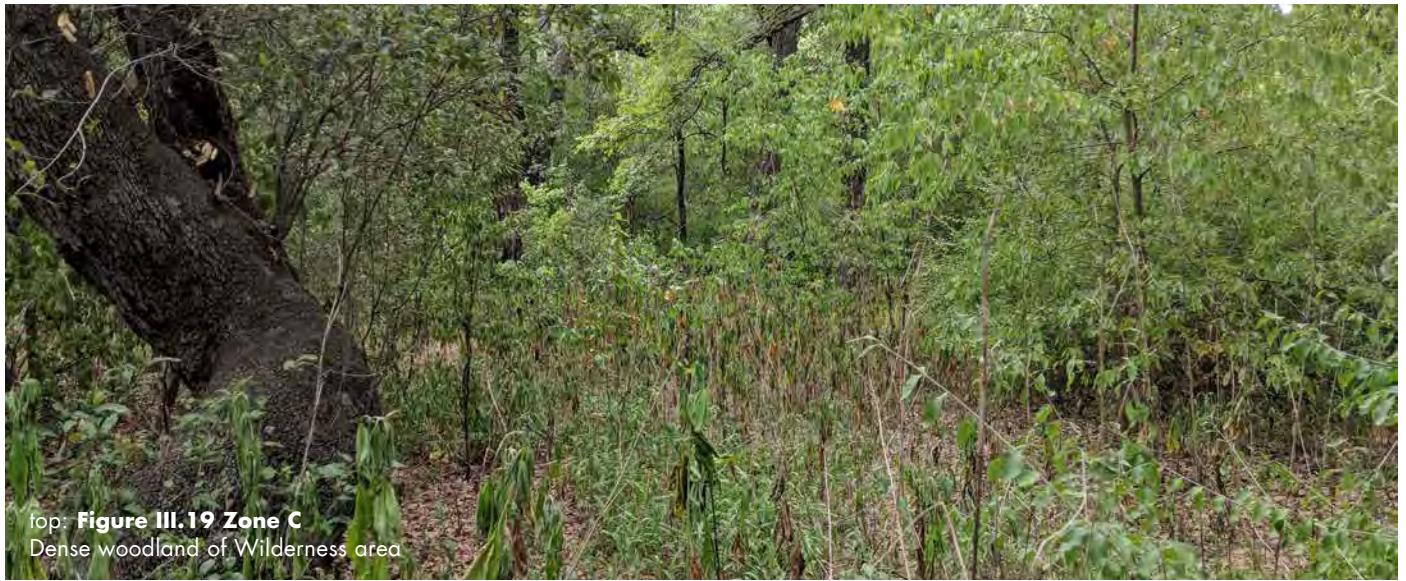
Description: The wilderness area, an upland community within the Southern Clay Loam ecological site, has completed the transition from the Prairie State to the Shrubland State and represents a Dense Woodland Community (Figure III.19). The overstory canopy cover is 75–100% and is dominated by live oak and cedar elm. The mid-story covers approximately 75% of the area. The invasive Japanese privet is locally dominant and Chinaberry is occasional. Natives such as elbow bush, cedar elm, hackberry and Texas persimmon are common. Soapberry (*Sapindus saponaria*), sotol (*Dasylirion texanum*) and Eve’s necklace (*Styphnolobium affine*) are occasional. A healthy herbaceous layer is present, making up 50 to 75% of the area and containing desirable species such as Virginia wildrye. Very little bare soil exists and litter covers approximately 75% of the soil (Figure III.20). The woody component is quite diverse and healthy. The invasive bamboo is locally dominant, as is catclaw vine. These

top: **Figure III.19 Zone C**
Dense woodland of Wilderness area

Opportunities: Overall, the community is healthy. However, the woody density is too high, which reduces the vigor of existing individuals and places the woodland at higher risk for a stand replacing fire. The stands of invasive bamboo pose a particular threat because they ignite easily, conduct fire readily, and inhibit water application by firefighters. Selective thinning of the woodland to reduce fuel loads, encourage a healthy, uneven, age structure and to support overall diversity is recommended (Figure III.21). Thinning approximately 30% of existing stems, over 3-5 years, would enhance the overall health of the site. The primary focus of thinning should be removing invasive species, reducing ladder fuels under larger trees, and ensuring an uneven age structure for remaining species. Enhanced diversity will encourage healthy soil, which will increase the uplands ability to capture, infiltrate and clean water, thus supporting river health. Following initial thinning, density maintenance will need to occur on an ongoing basis. It is recommended that a woodland management plan be created for this area with a focus on woodland health and firewise management.

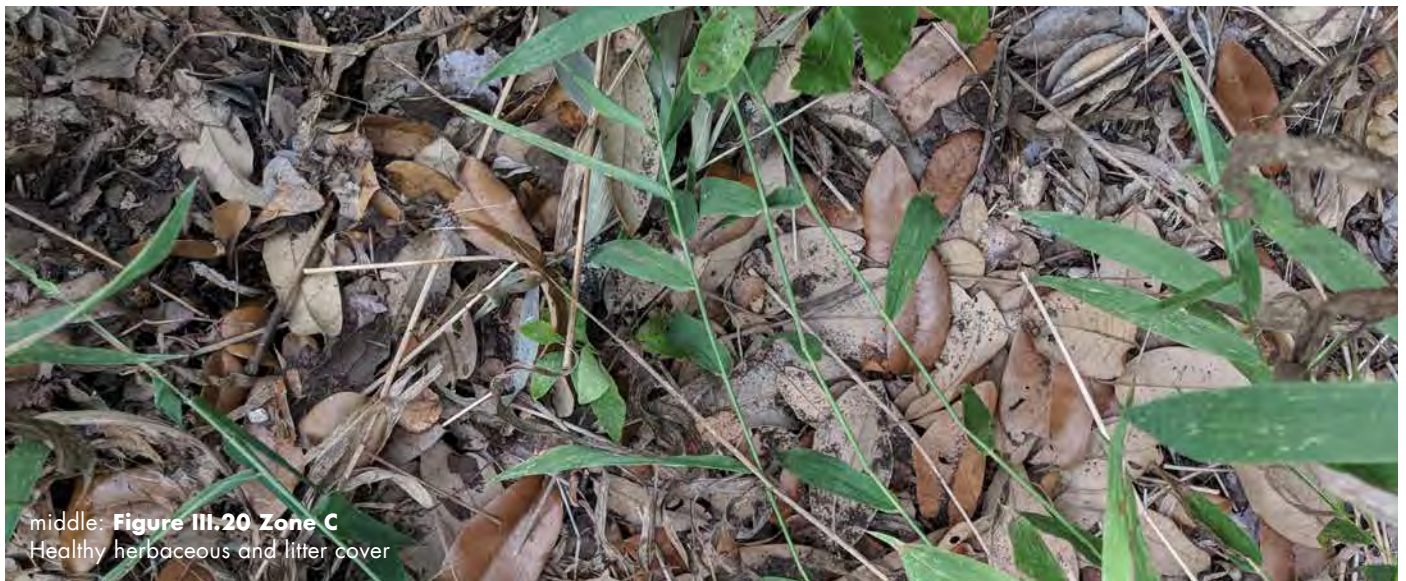
middle: **Figure III.20 Zone C**
Healthy herbaceous and litter cover

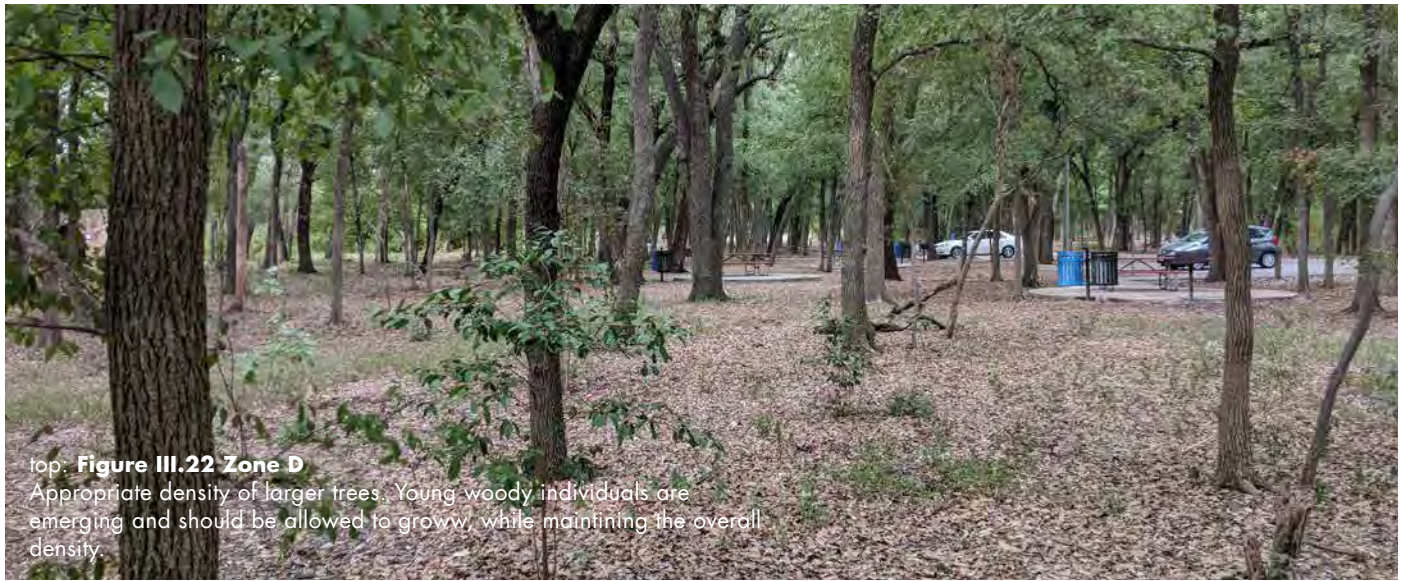
Description: This upland Southern Clay Loam site is currently a Dense Woodland Community (Figure III.22). The overstory approaches 100% and is dominated by live oak and cedar elm. A diverse midstory exists and shades approximately 25% of the site. Mid-story species include Texas persimmon, anaqua (*Ehretia anacua*) and hoptree (*Ptelea trifoliata*) (Figure III.23, Figure III.24). Most mid-story species are 4"DBH (diameter at breast height) or less. Very little bare ground is present (<5%), and litter cover approaches 100%. The soil surface condition is good, with high organic matter (13%), good structure and limited compaction. Bamboo is locally dominant near the former nursery area and is serving to conceal a feral cat colony.

top: **Figure III.22 Zone D**
Appropriate density of larger trees. Young woody individuals are emerging and should be allowed to grow, while maintaining the overall density.

Opportunities: The soil and vegetative community are in good condition. Monitoring, maintaining current density, and encouraging appropriate age structure among the woody species will keep the site in good condition. Young shrubs and trees are emerging and should be allowed to grow, while maintaining the overall current density of the area. Shade tolerant perennial grasses and forbs can be added to enhance the site's ability to infiltrate and clean water if desired.

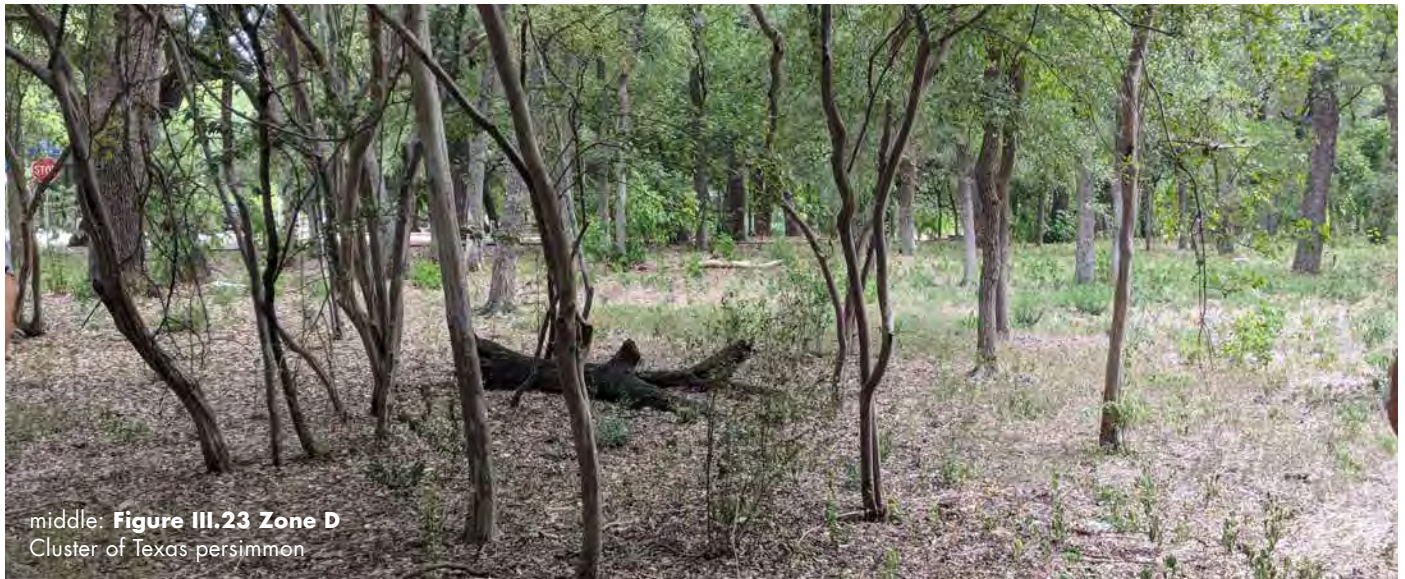
middle: **Figure III.23 Zone D**
Cluster of Texas persimmon

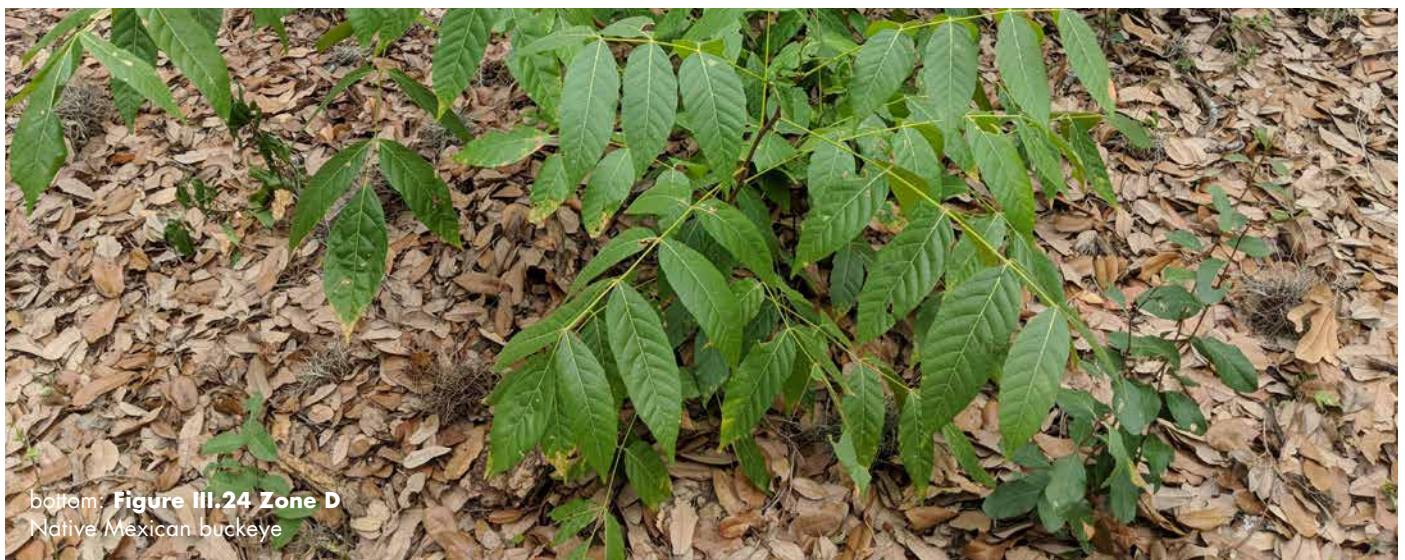
bottom: **Figure III.24 Zone D**
Native Mexican buckeye

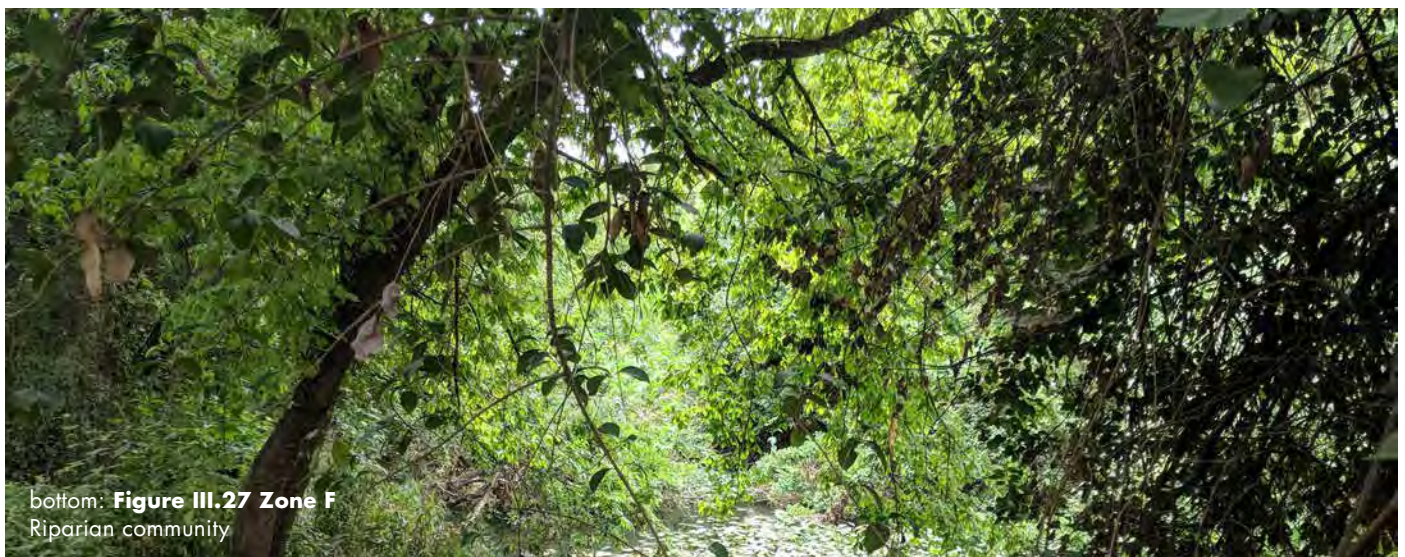
bottom: **Figure III.27 Zone F**
Riparian community

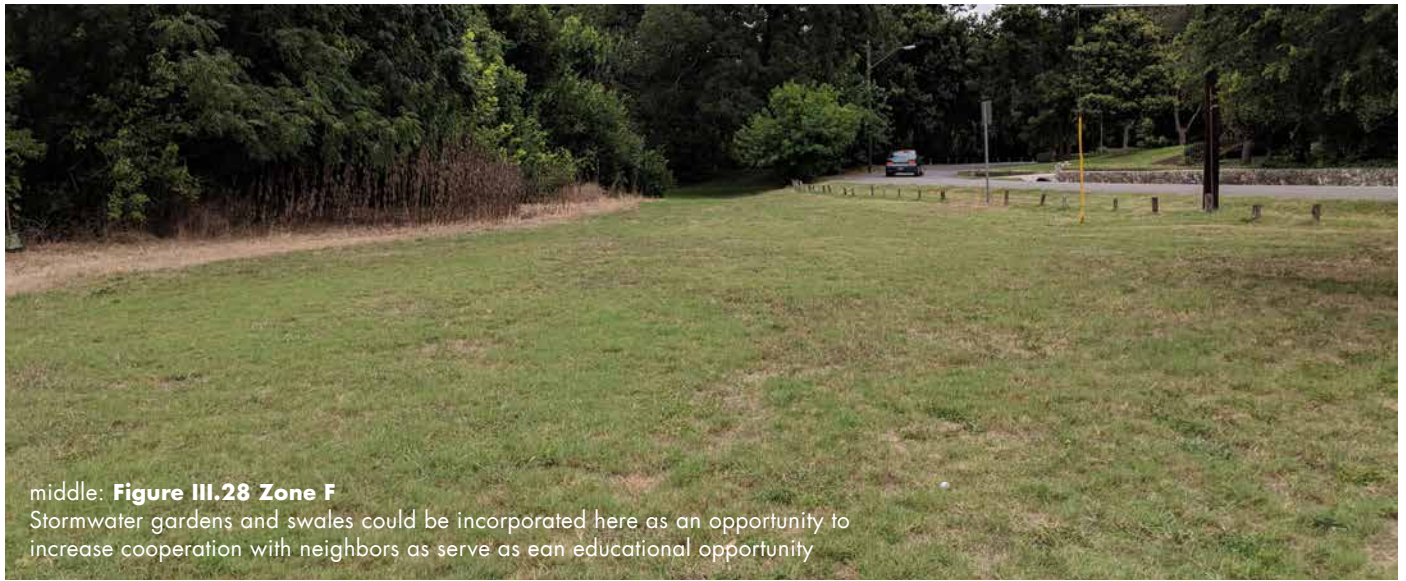
middle: **Figure III.28 Zone F**
Stormwater gardens and swales could be incorporated here as an opportunity to increase cooperation with neighbors as serve as an educational opportunity

The area between the river and neighborhood represents a secondary opportunity for educational LID features – these focusing on beauty, techniques homeowners can apply and engaging the neighborhood in river stewardship. Areas supporting St Augustine grass indicate sufficient water to maintain a raingarden.

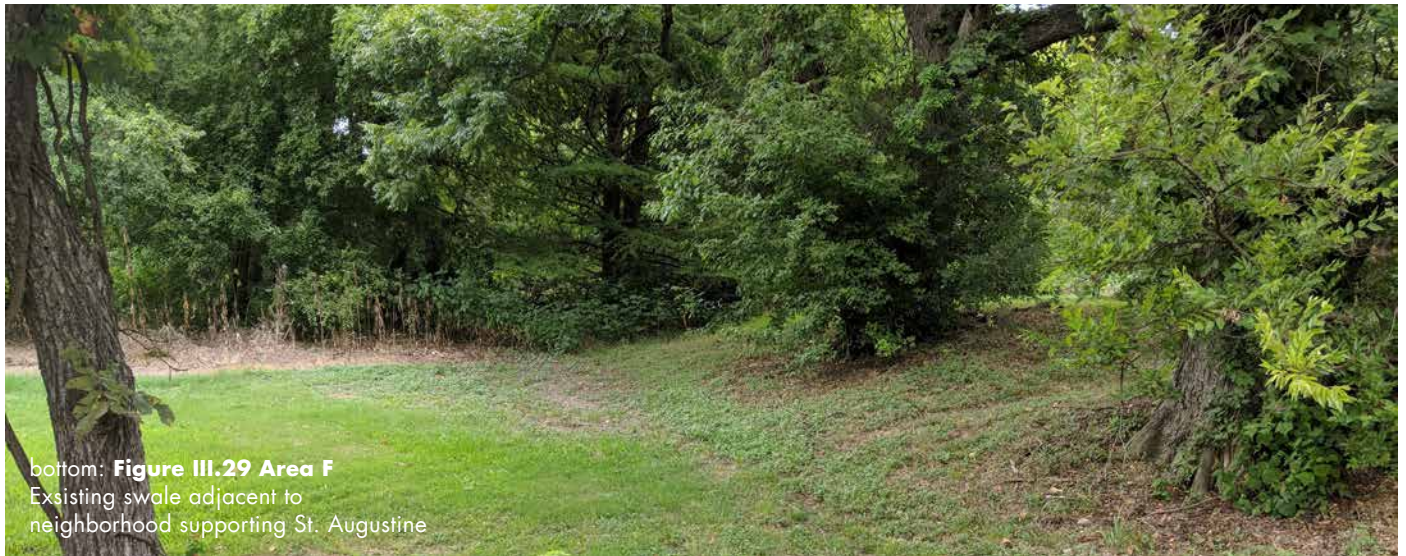
bottom: **Figure III.29 Area F**
Existing swale adjacent to neighborhood supporting St. Augustine

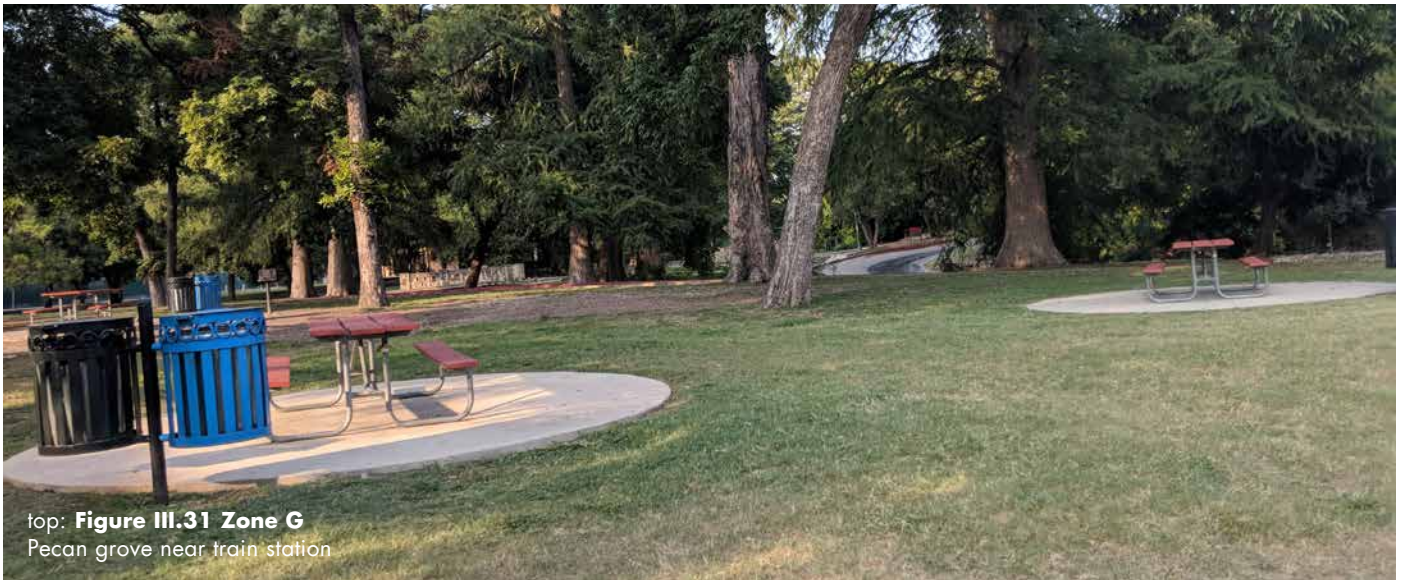
top: **Figure III.31 Zone G**
Pecan grove near train station

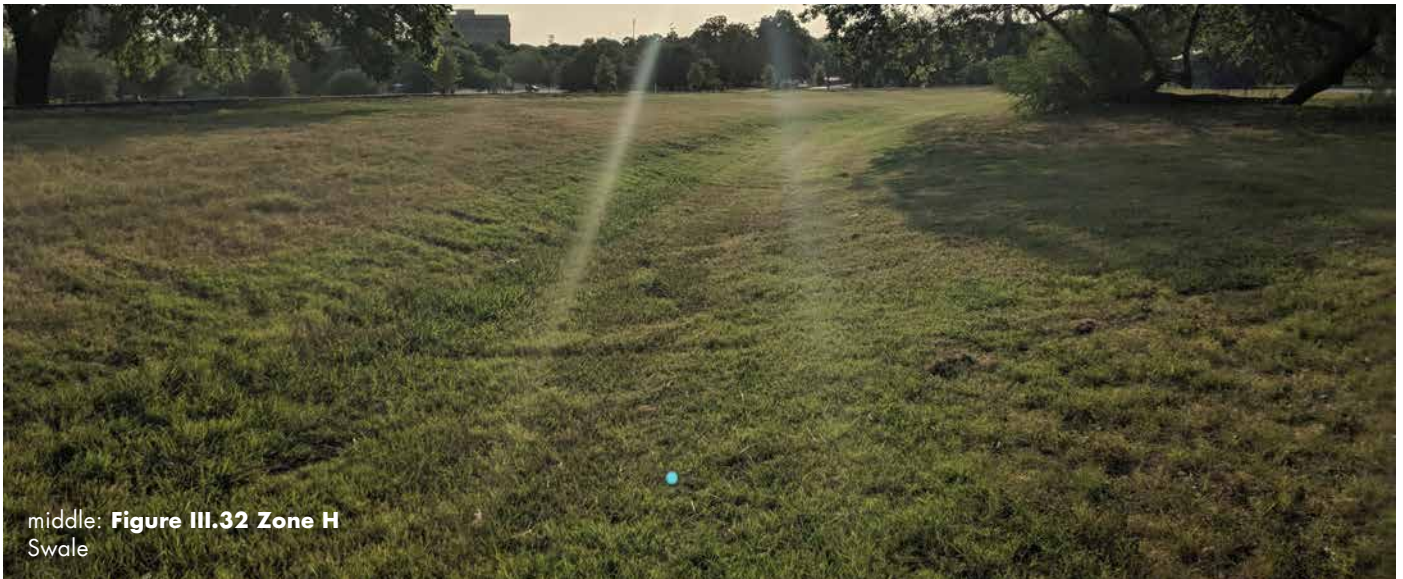
Description: The area has 100% herbaceous cover consisting mainly of Bermudagrass, though the native buffalograss and several native forbs are present within the swale (Figure III.32). Most of the site has no evidence of erosion, except a point of gully erosion near the eastern end of the swale (Figure III.33).

middle: **Figure III.32 Zone H**
Swale

Opportunities: SARA conducted an overland flow analysis of the area which reveals that a substantial area is draining to this swale and converging on the erosion point.

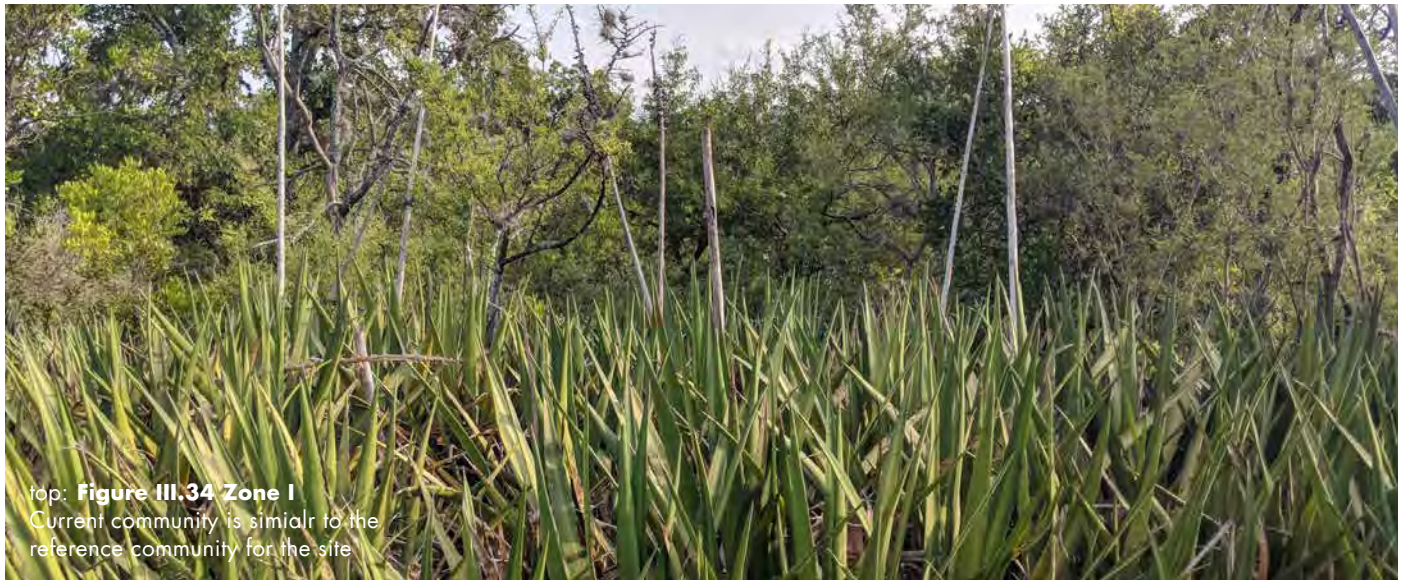
top: **Figure III.34 Zone I**
Current community is similar to the
reference community for the site

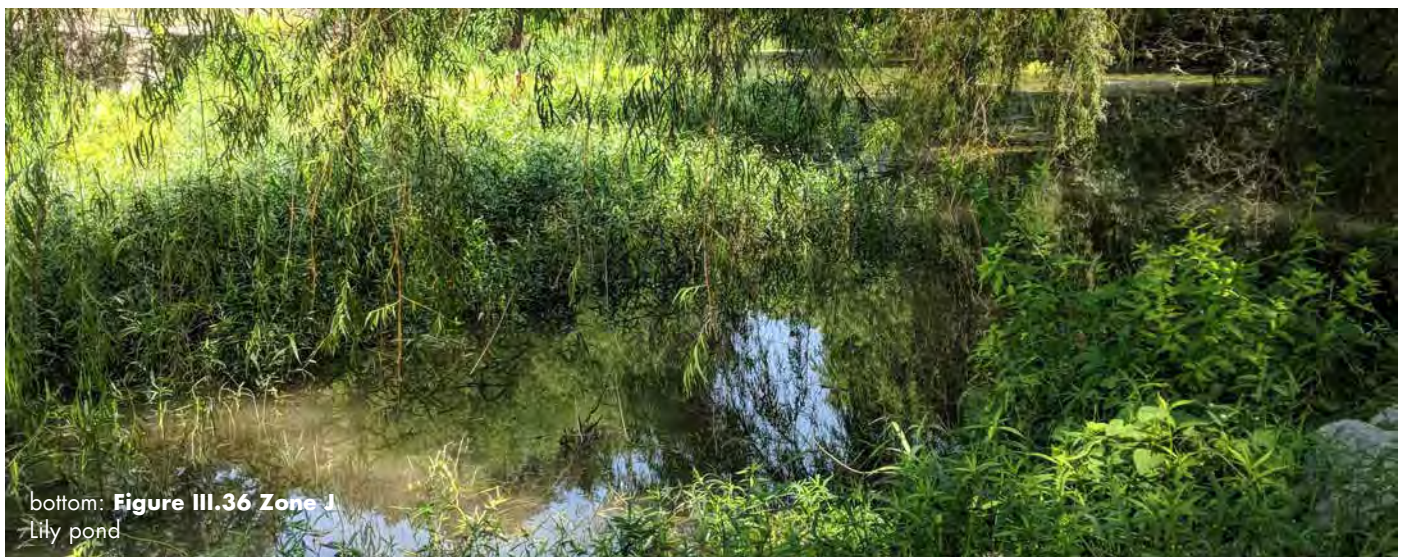
bottom: **Figure III.36 Zone J**
Lily pond

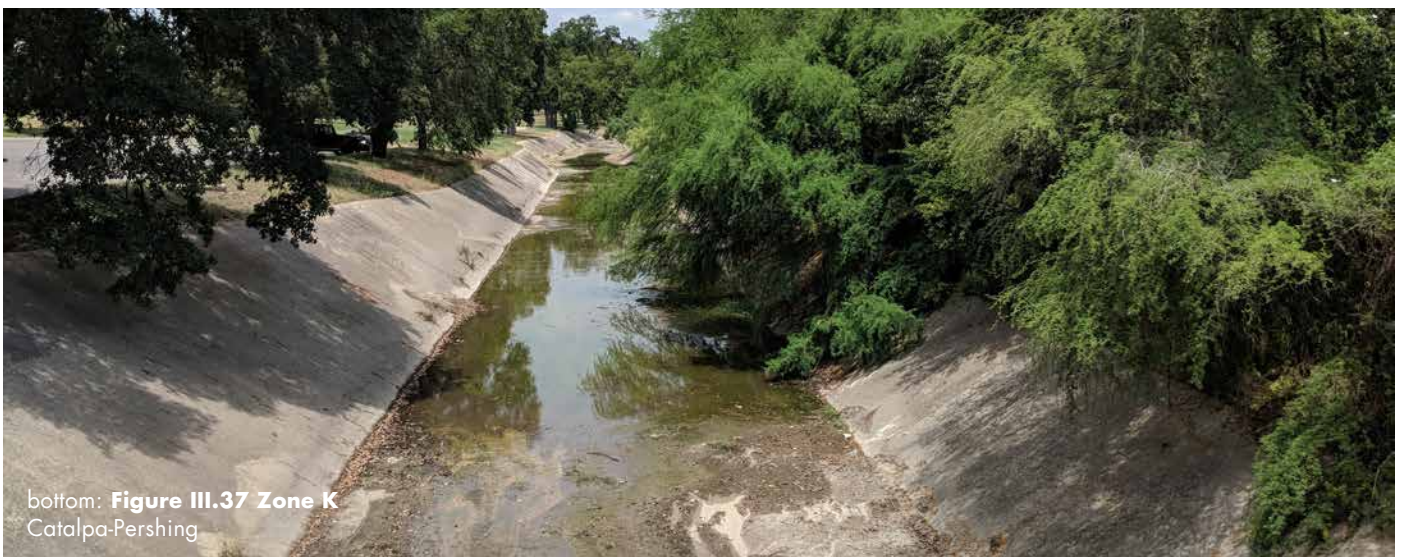
bottom: **Figure III.37 Zone K**
Catalpa-Pershing

Opportunities: Restoration of Catalpa Pershing will require a multidisciplinary design team including engineers, design professionals, ecologists, soil scientists, maintenance professionals and members of owner organizations. The recommendations made here assume that naturalization of the channel is the goal as described in the master plan, and pertain only to ecological considerations. Engineering, human experience, historical/cultural considerations and connectivity will need to be considered as well.

The natural channel design should be based on hydrologic and hydraulic modelling to ensure the channel conducts stormwater appropriately and to determine the appropriate ratio and location of naturalized vs. reinforced banks. The goal is to incorporate meander, reduce bank slope, allow for bank revegetation and create complex in-stream habitat. If allowable within modelling constraints, incorporate obstructions to simulate the role of large woody debris in creating further habitat complexity and varied depositional patterns.

Pending engineering evaluation, it does not appear that sufficient width exists on the eastern side of the channel to allow the banks to lay back enough for naturalization. However, the western bank is dominated by invasive species and there is some distance between the channel and the large diameter trees found in the woodland. Consider retaining the eastern concrete slope and regrading the western bank to allow for some meander and reduced slopes. The meander pattern will need to be matched on the eastern bank, perhaps by building out from the existing channel.

Naturalized slopes will likely require complete reconstruction of the plant and soil community. Soils must contain sufficient organic matter and clay content to support vigorous riparian communities, and compaction following construction cannot exceed levels that allow root growth. The maximum allowable compaction varies with soil composition and moisture content, but a useful rule of thumb is that proctor densities beyond 80-85% significantly impede root growth. Soil and plant specification will need to be tightly integrated, and sourcing needs to begin early in the design process to ensure sufficient volume of both plant and soil amendments at construction. New soil tends to be low in organic matter, which will need to be rectified with static aged, low nutrient compost. This product is difficult to find. Most composts are turned frequently and sold while still young. Static aged compost can be purchased, or young compost can be purchased and then aged. Regardless, set aside funds and time for testing and storage. Including a soil scientist on the design team is strongly recommended.
