ECOLOGICAL SITE ASSESSMENT

BRACKENRIDGE PARK

Brackenridge Park Conservancy
San Antonio, Texas

August, 2019

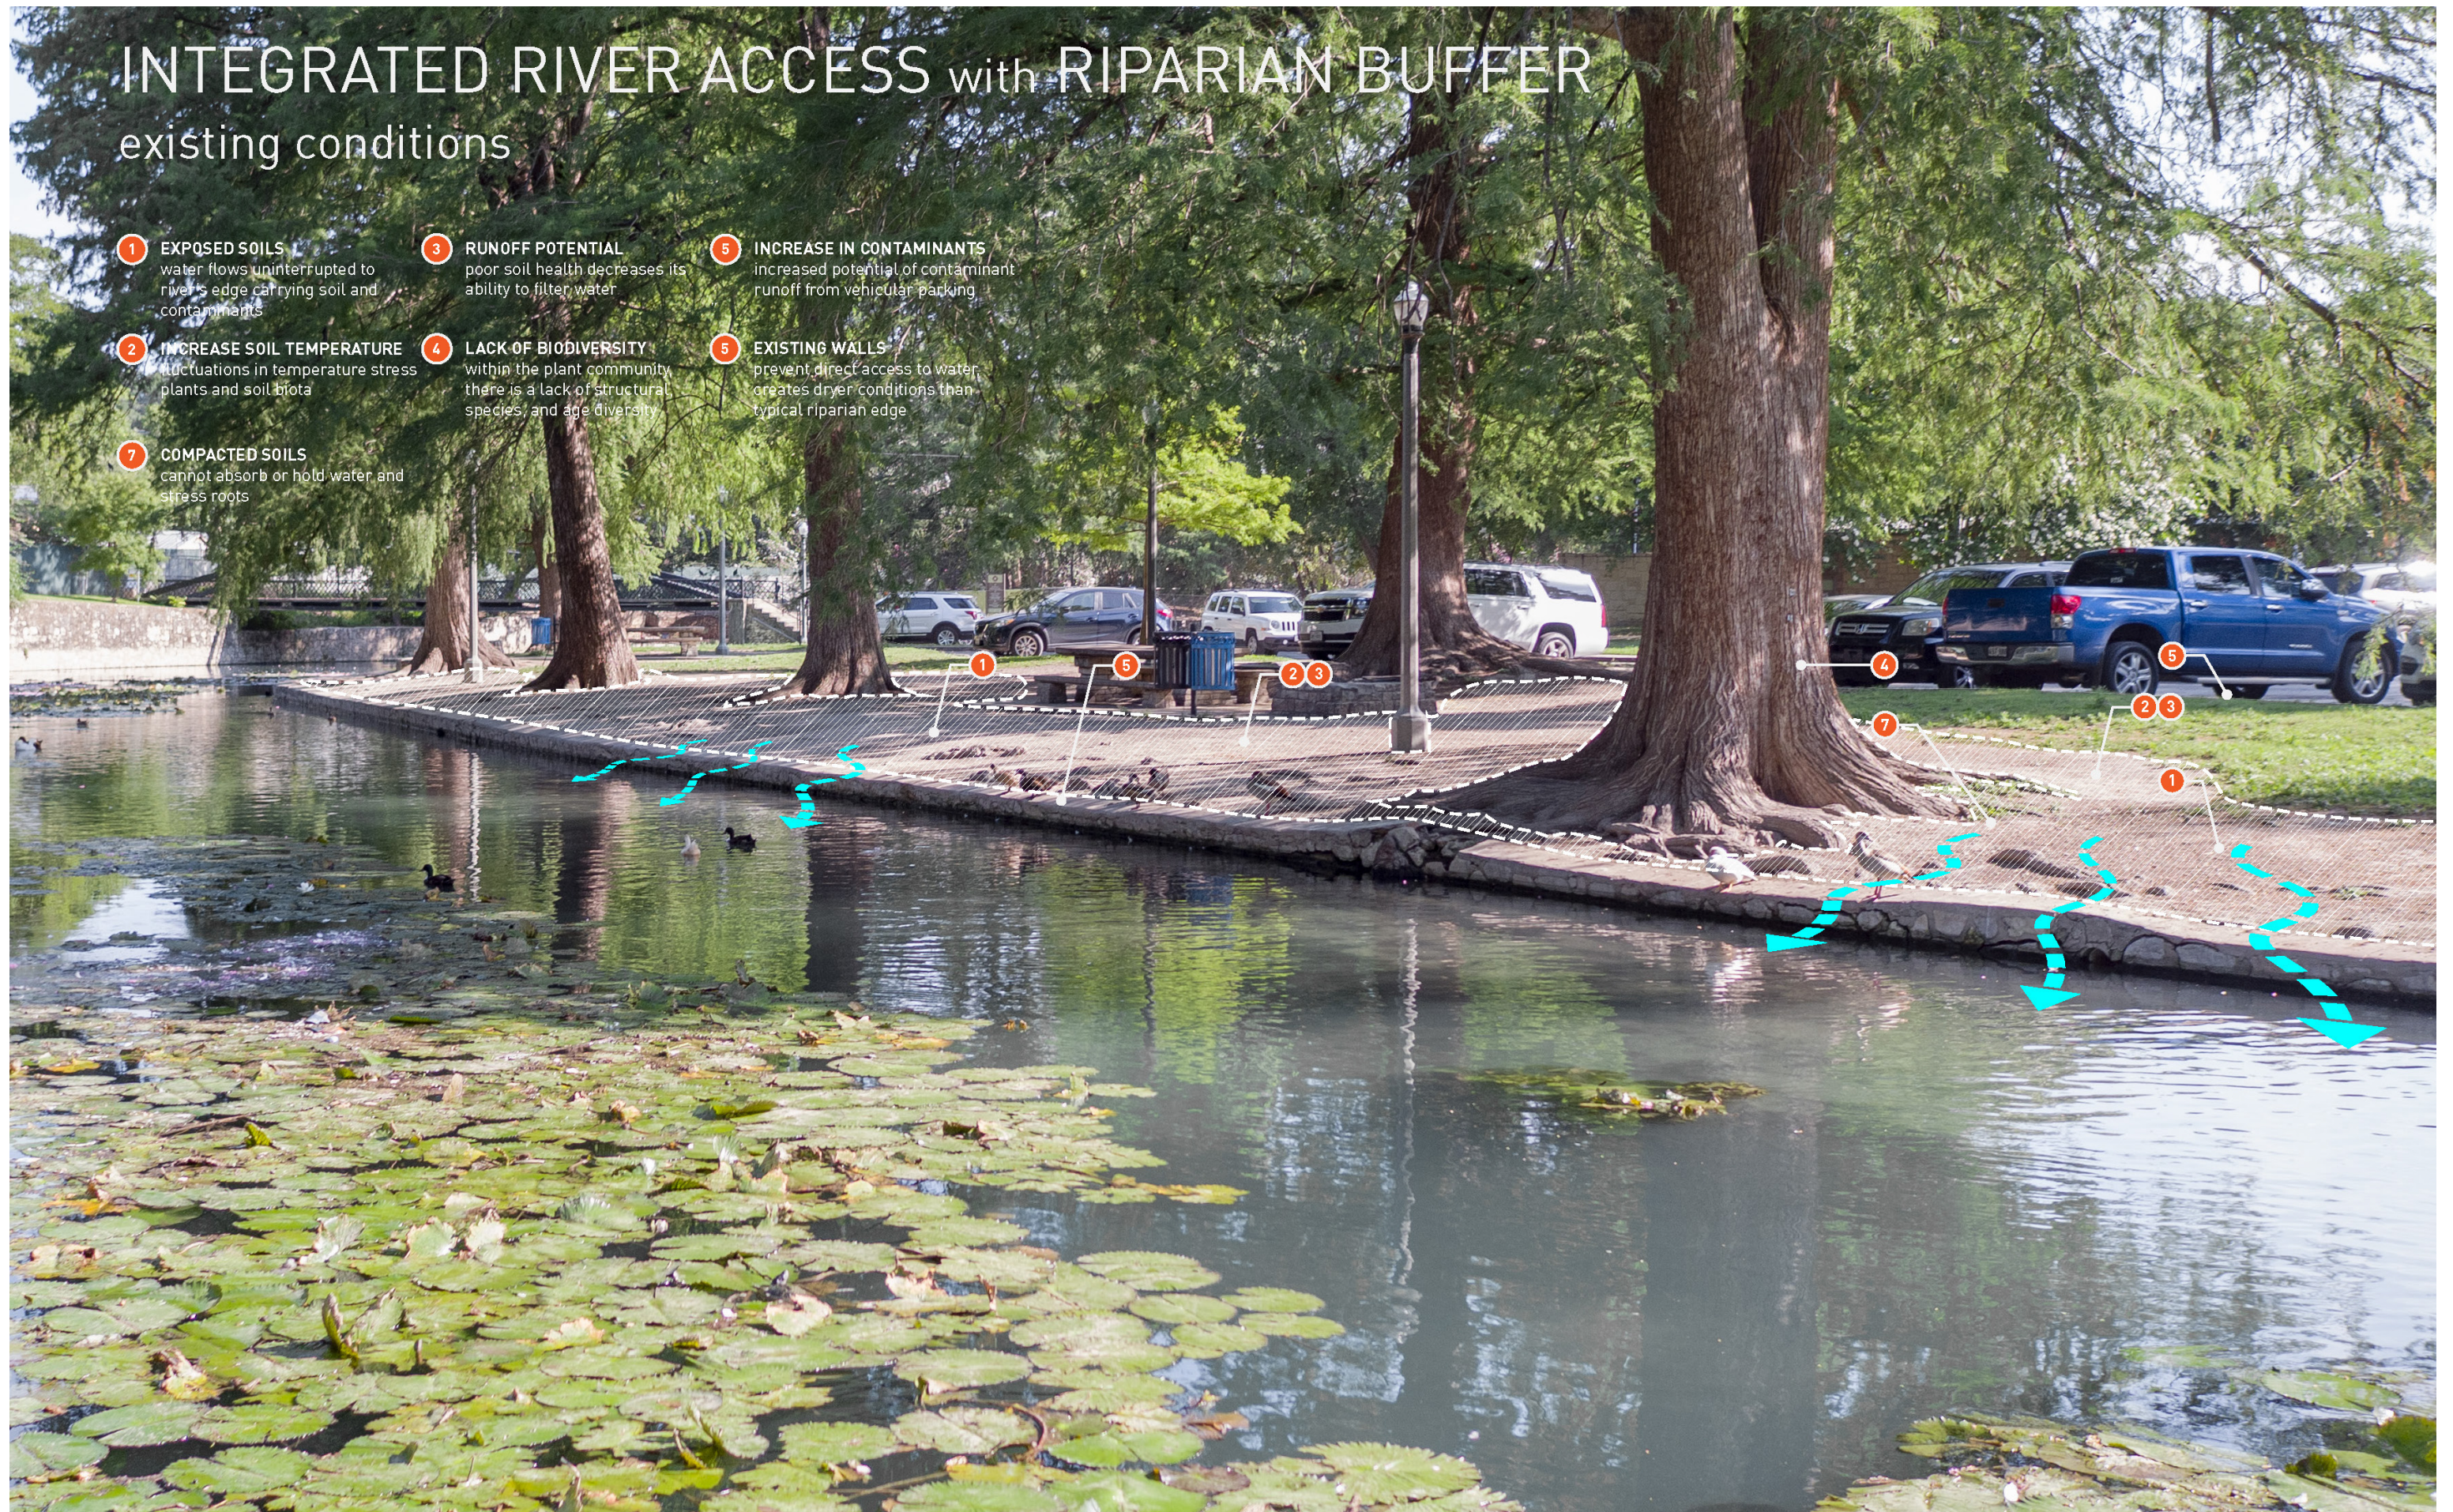
INTEGRATED RIVER ACCESS with RIPARIAN BUFFER

existing conditions

- 1 **EXPPOSED SOILS**
water flows uninterrupted to river's edge carrying soil and contaminants
- 2 **INCREASE SOIL TEMPERATURE**
fluctuations in temperature stress plants and soil biota
- 3 **RUNOFF POTENTIAL**
poor soil health decreases its ability to filter water
- 4 **LACK OF BIODIVERSITY**
within the plant community there is a lack of structural species and age diversity
- 5 **INCREASE IN CONTAMINANTS**
increased potential of contaminant runoff from vehicular parking
- 5 **EXISTING WALLS**
prevent direct access to water creates dryer conditions than typical riparian edge
- 7 **COMPACTED SOILS**
cannot absorb or hold water and stress roots

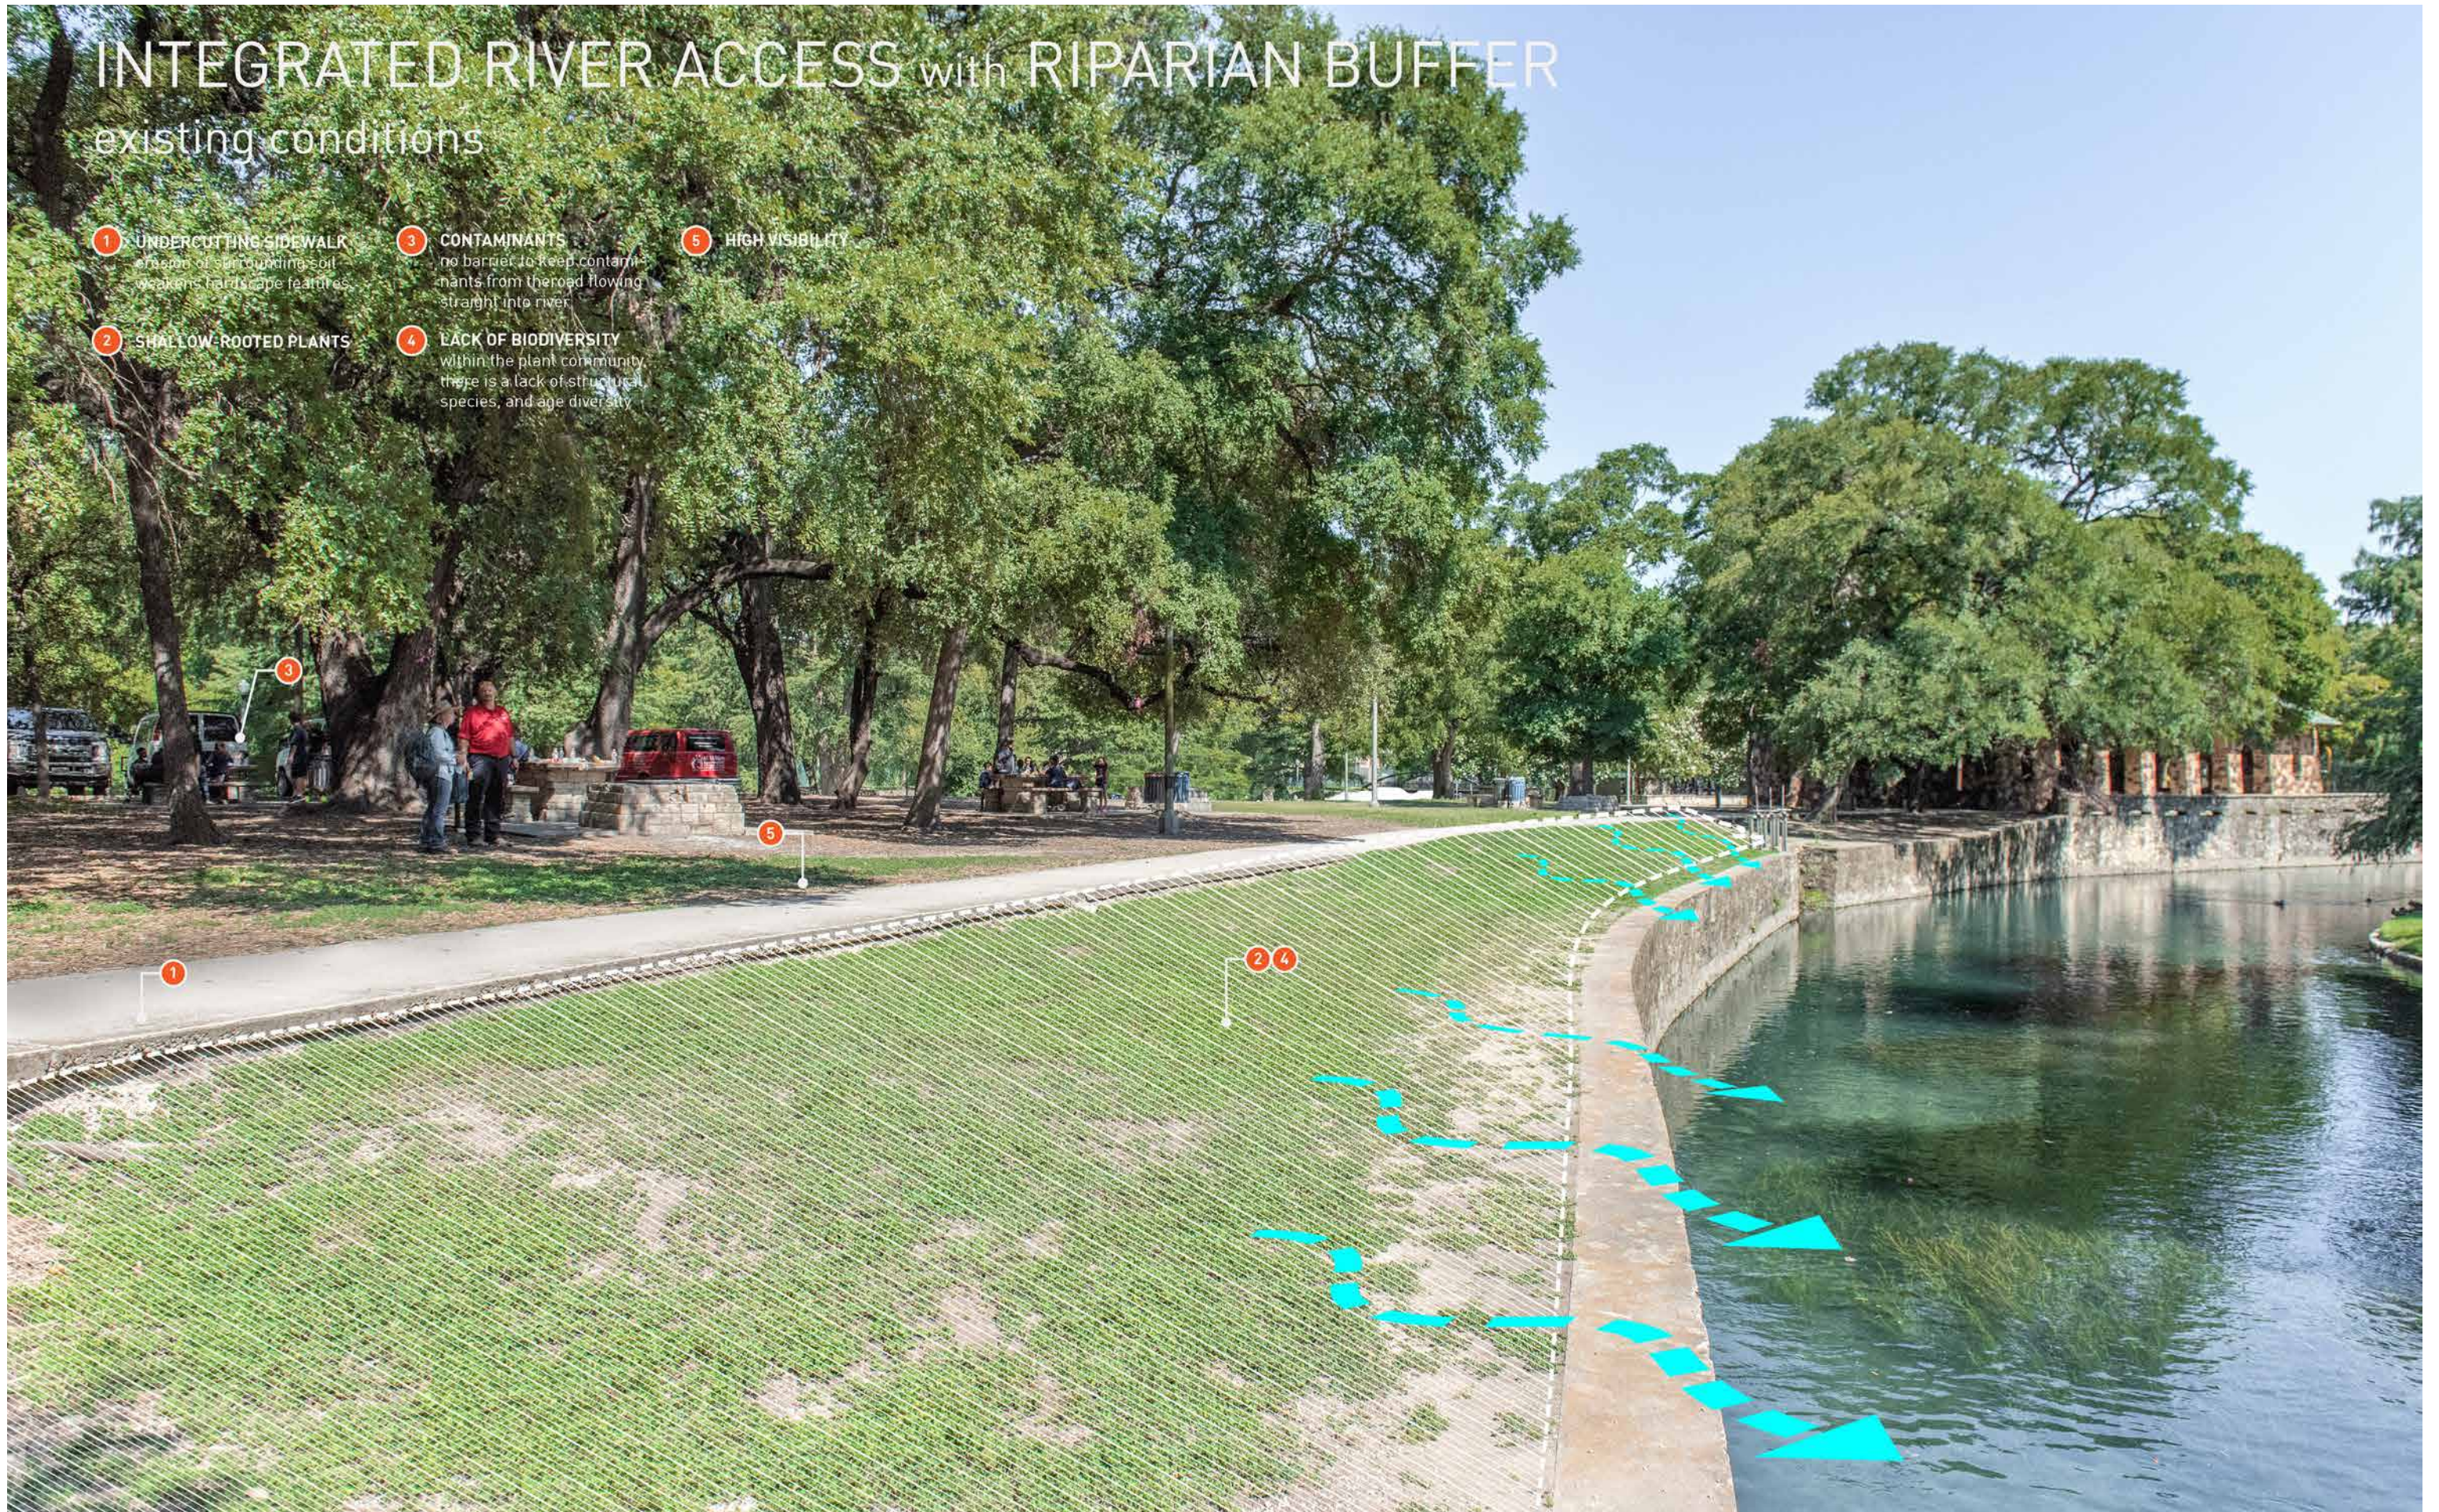
INTEGRATED RIVER ACCESS with RIPARIAN BUFFER

existing conditions

4 LACK OF BIODIVERSITY
within the plant community
there is a lack of structural
species, and age diversity

5 HIGH VISIBILITY

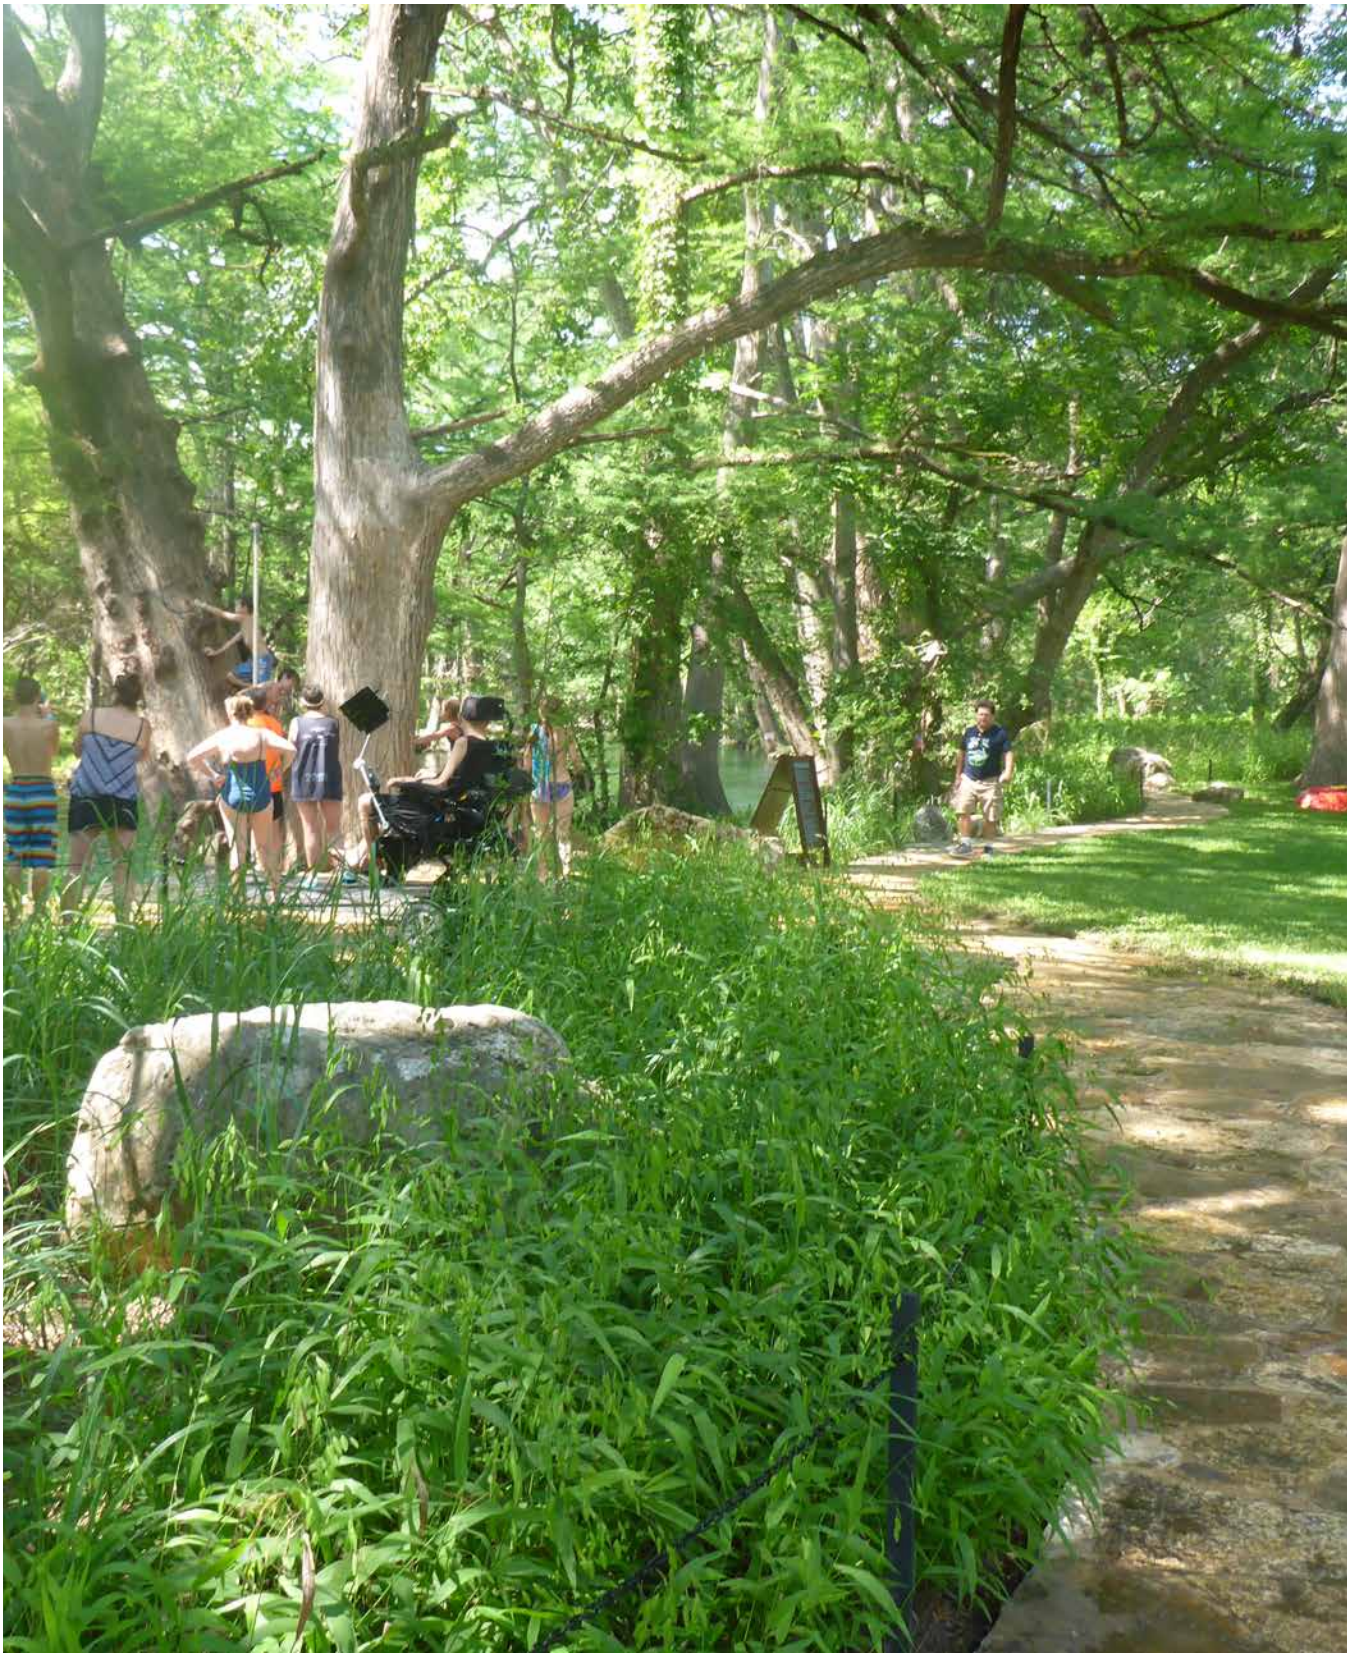
Figure III.14 Precedent Project - Blue Hole Regional Park, Wimberley, Texas

Create a system of restored riparian buffers, focusing on stability plantings with high aesthetic value and moderate maintenance requirements, paired with reinforced access and viewing points. Couple with network of LID features and upland restoration.

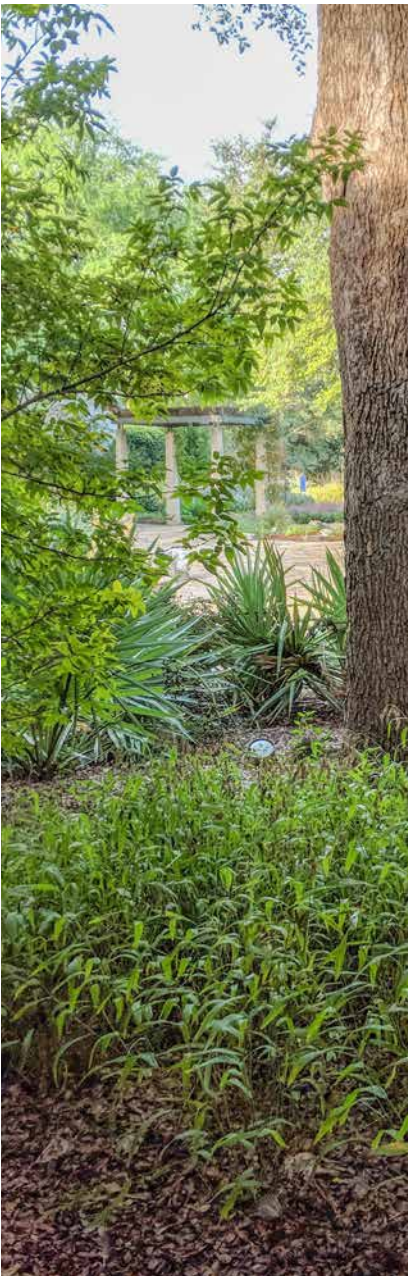
top: **Figure III.18 Protective planting**
Low to knee high plantings can be used to cool and protect critical root zones and to influence traffic patterns. Maintenance requirements of plantings must be matched with maintenance capacity for the area.

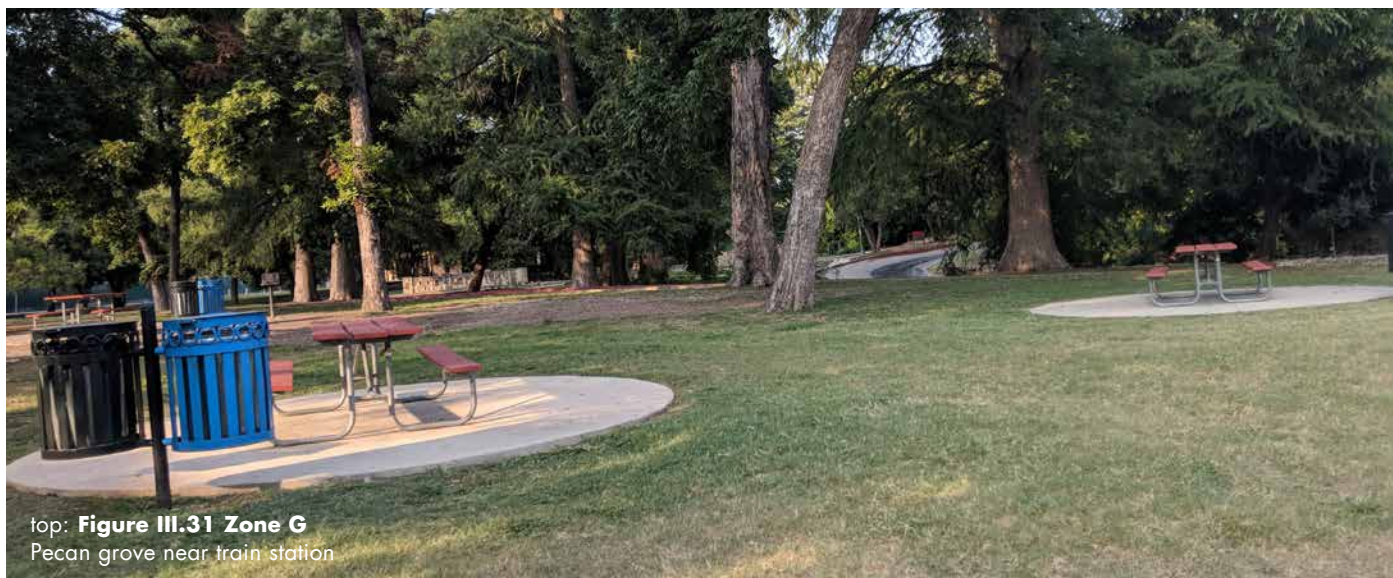
top: **Figure III.31 Zone G**
Pecan grove near train station

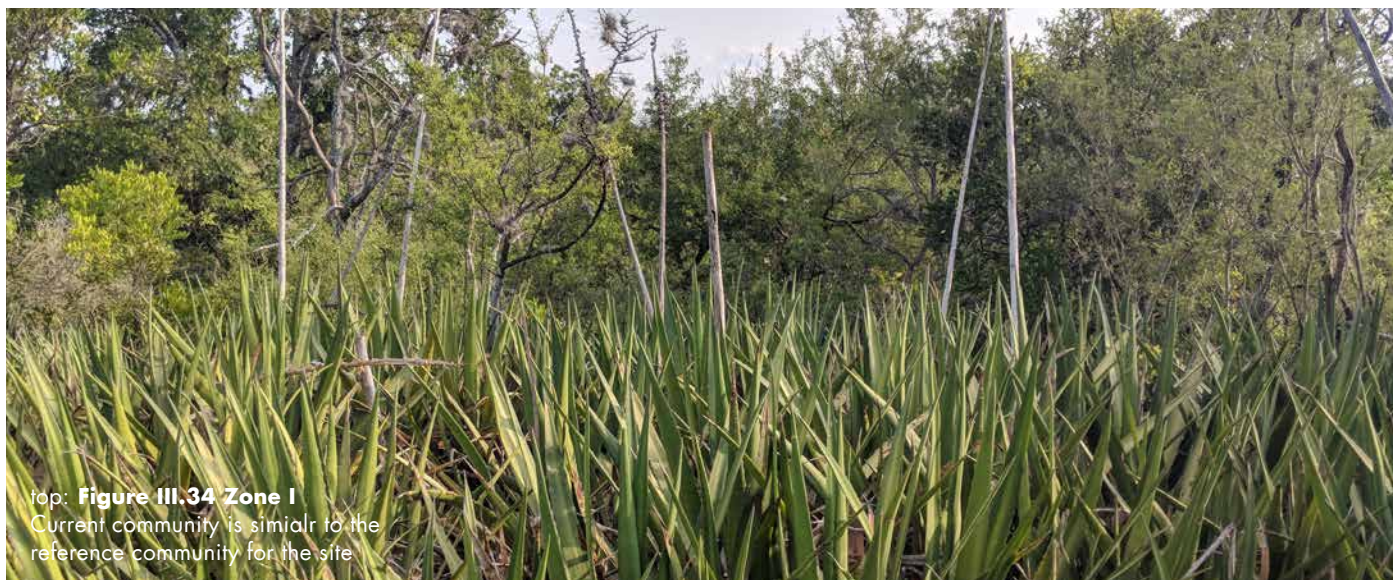
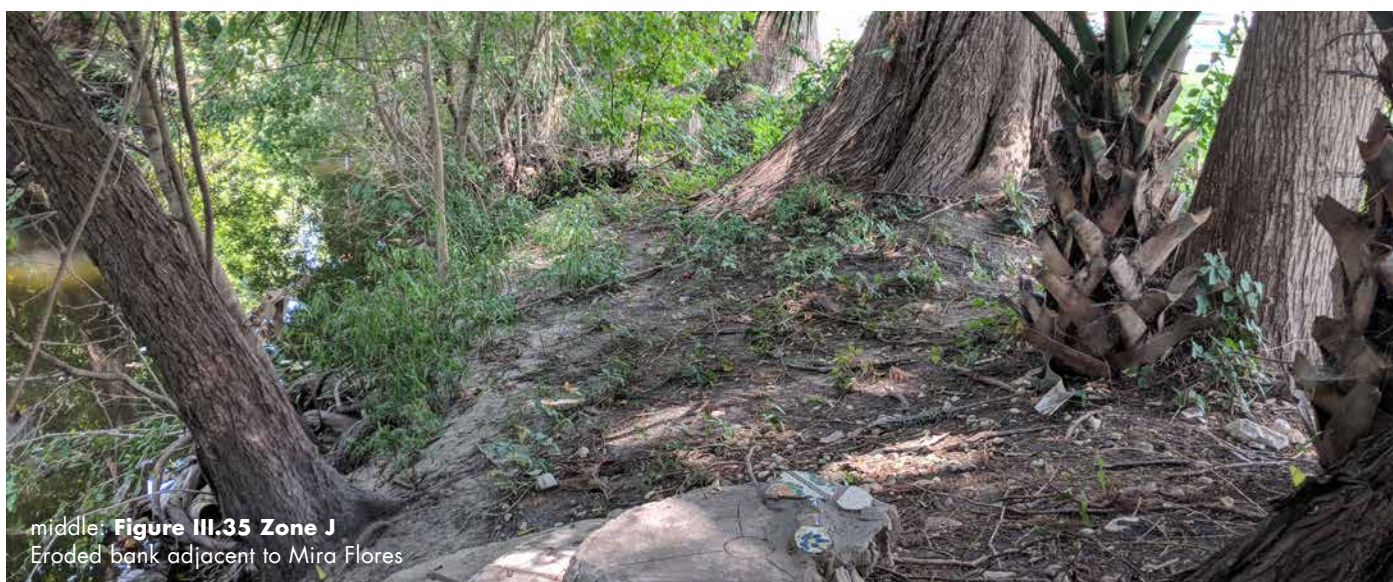
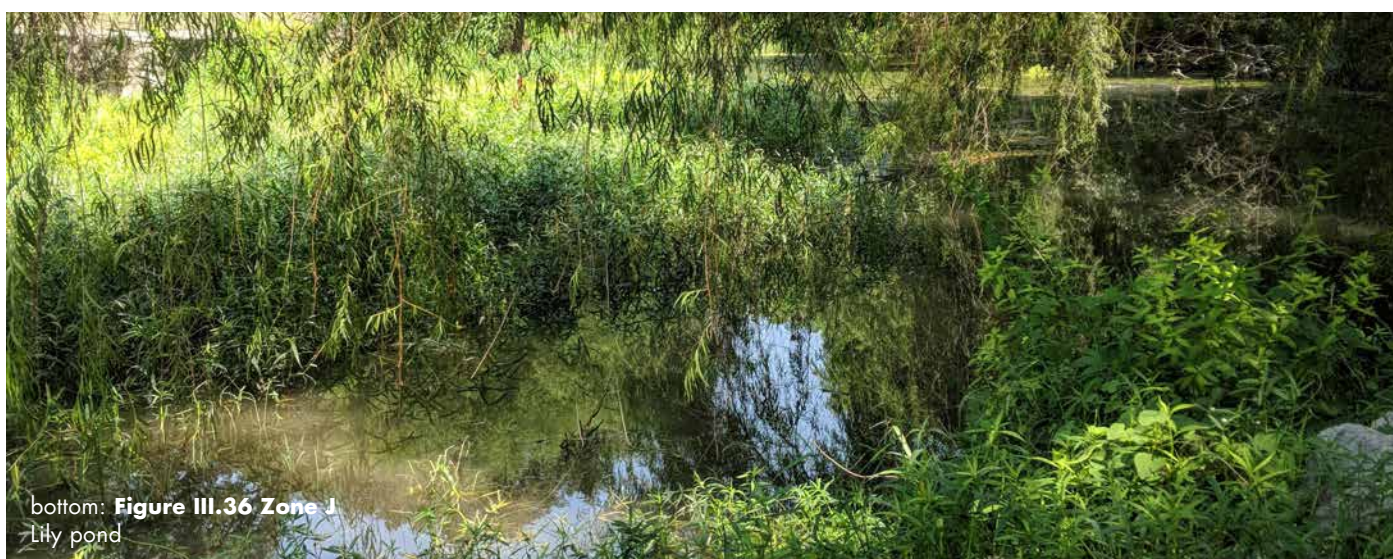
Description/Opportunities: A riparian community of varying width exists in this area, though it is generally narrow, lacking complexity and heavily infested with invasive species. The aquatic habitat is moderate here, with limited meander and low vegetative cover. Primary invasive species of concern include the dominant Japanese privet, catclaw vine, Chinaberry, Chinese tallow, Johnsongrass and Guineagrass along the bank. Brittons wild petunia, umbrella sedge and giant cane are locally dominant in several areas near or in the water. Raintree, white mulberry and loquat are present but populations are small and are of lower priority. Native species include bald cypress, pecan and live oak in the overstory. Black willow and boxelder are common in the midstory. Green ash, redbud (*Cercis canadensis*), possumhaw (*Ilex decidua*) and dogwood (*Cornus drummondii*) are present. Peppervine, giant ragweed and straggler daisy are abundant in the groundstory. Seedlings are primarily boxelder, hackberry and Japanese privet. Poison ivy is common. Erosion is common along the bank (Figure III.35, Figure III.26). Exposed honeycomb erosion matting is visible

adjacent to the AT&T parking lot. The area the park controls here is too narrow to mitigate the runoff from the parking lot causing the erosion. Addressing it requires slowing and capturing runoff further up-slope, which will necessitate cooperation with the current owner.
